Appendix H

SECTION 5B – MLS10

After 320 000 60 kN load applications

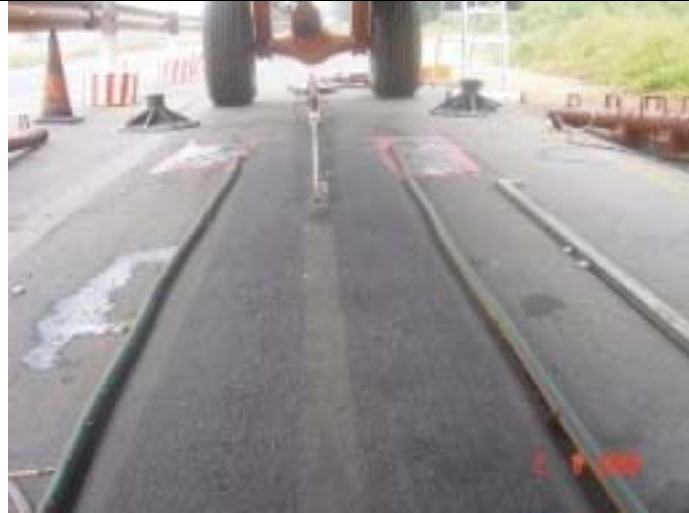
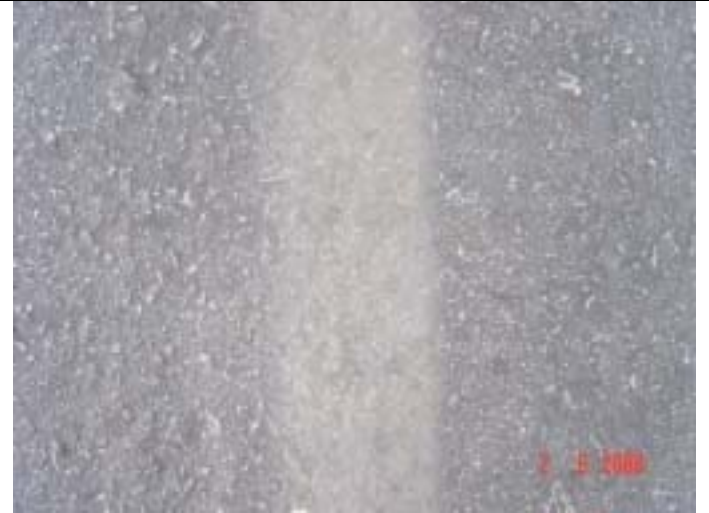
Pictorial overview of test section. HMA surface texture.

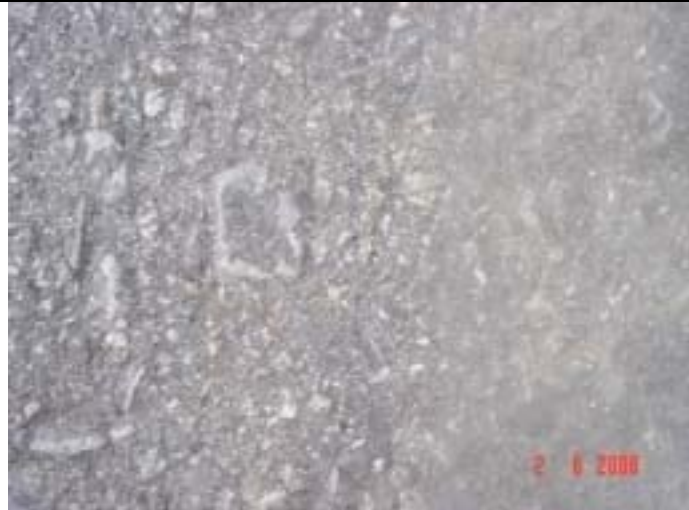
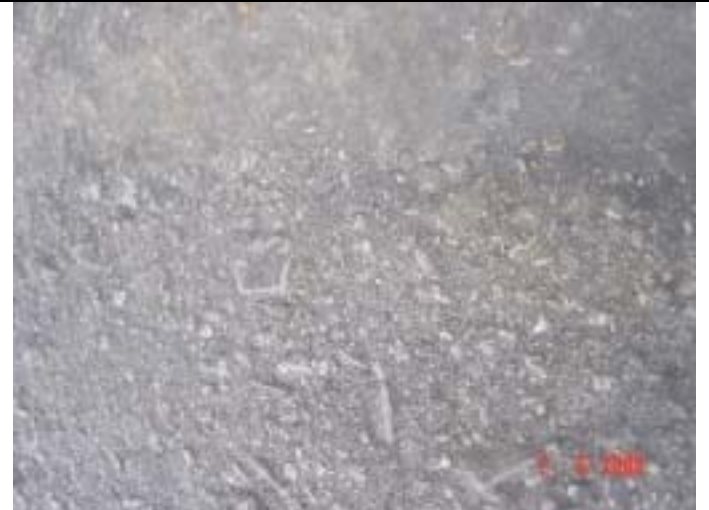
HMA surface texture. Note stripping of asphalt

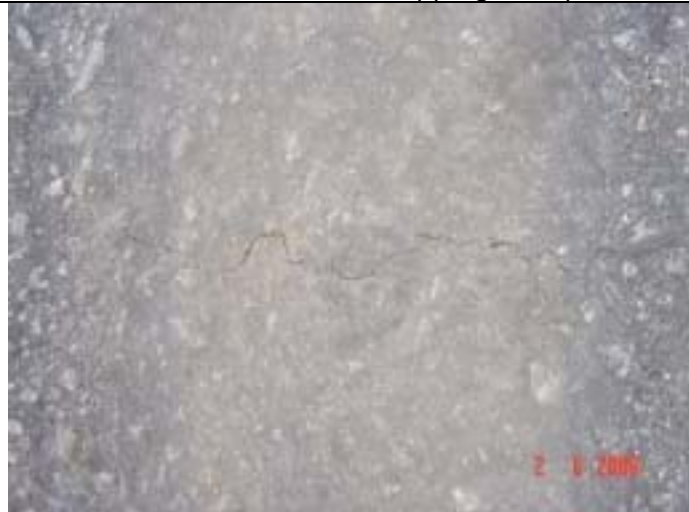
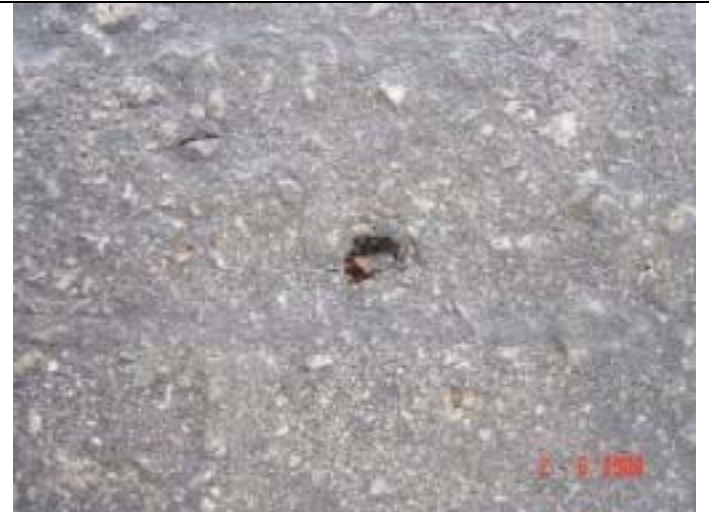
Transverse crack formation

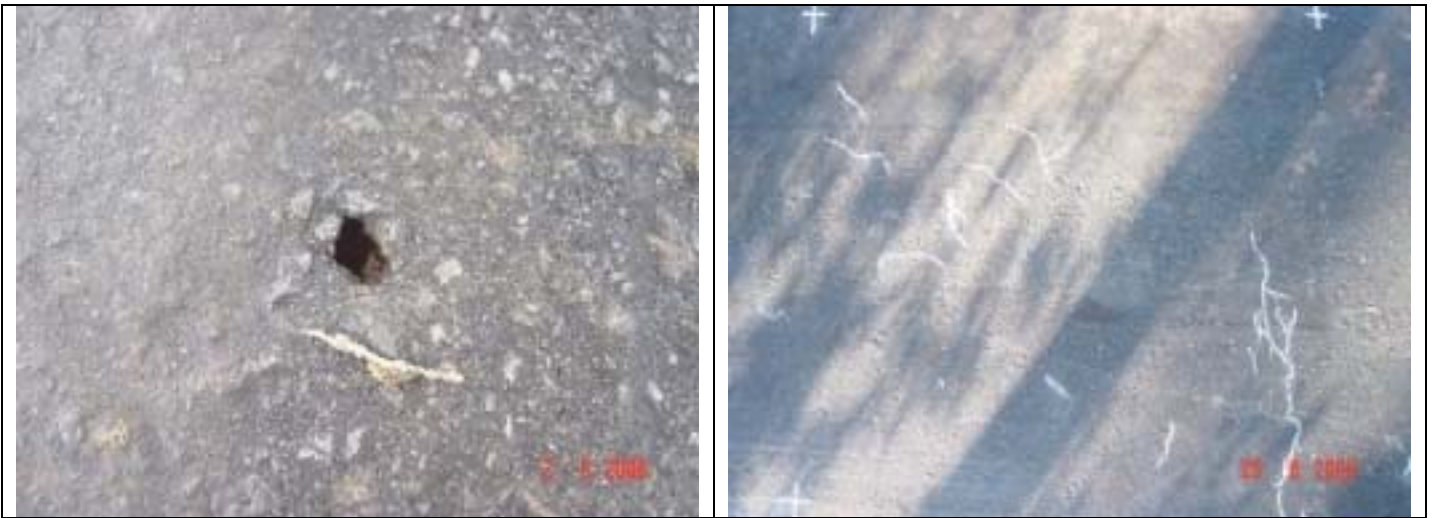
Asphalt surface texture. Plan view of test section

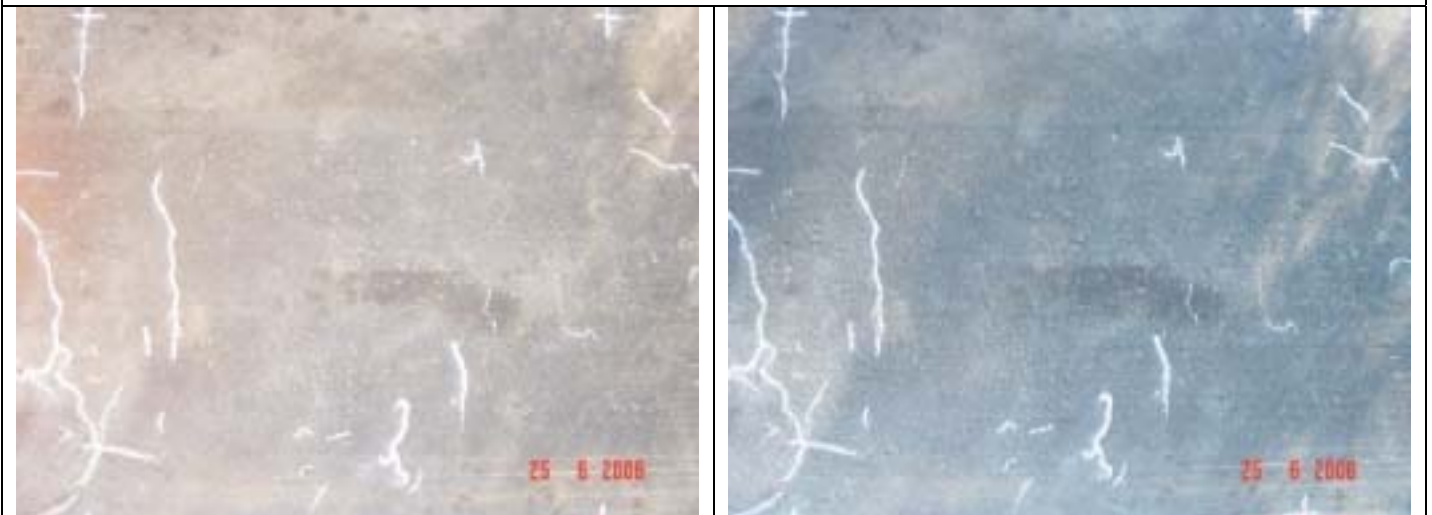
Plan views of test section with crack patterns marked with chalk

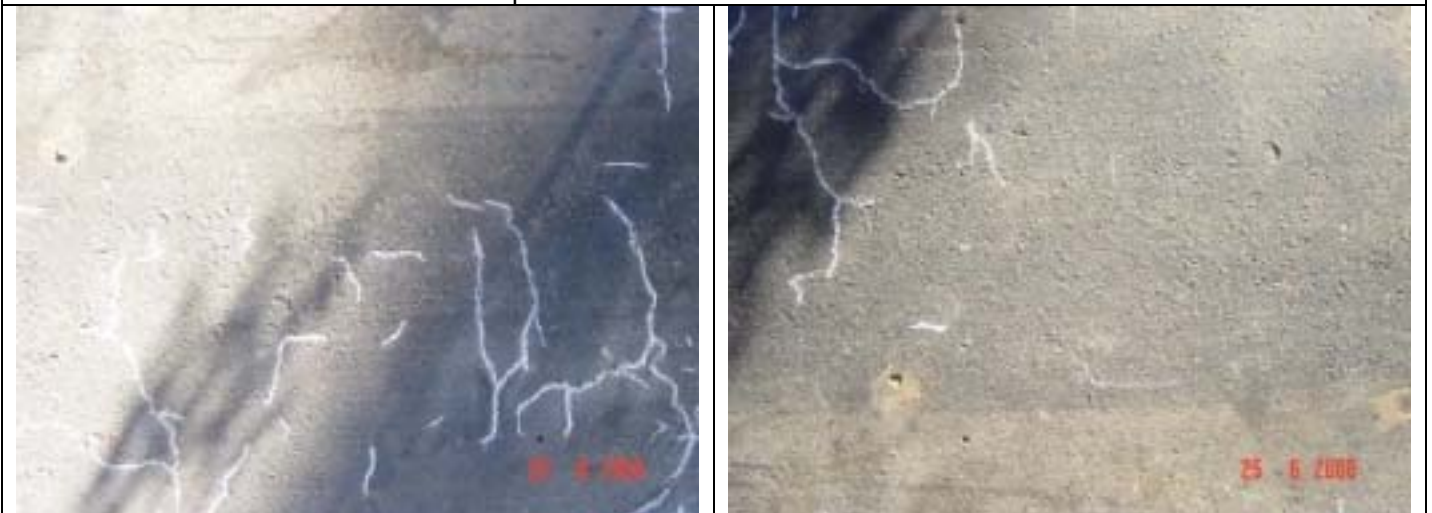
Plan views of test section with crack patterns marked with chalk

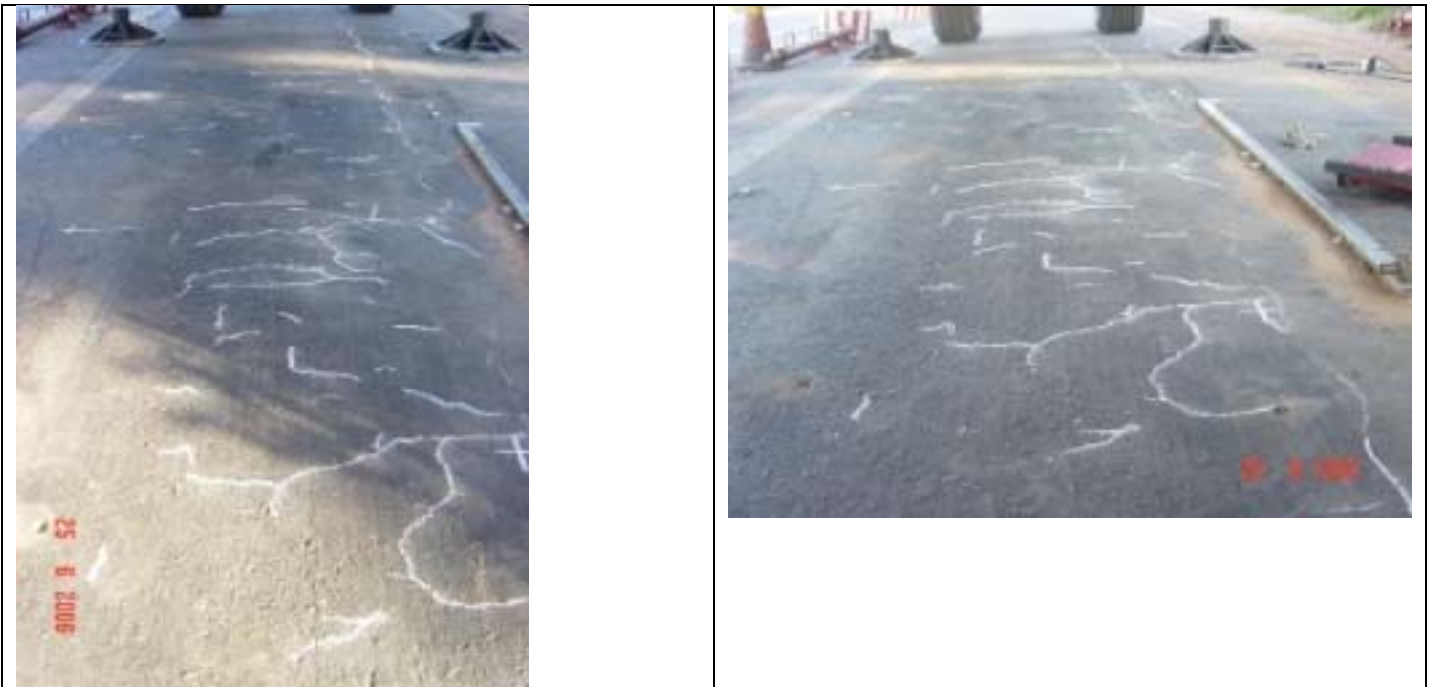
Pictorial overview of test section with crack patterns marked with chalk.
