Appendix I

SECTION 8C – MLS10

After 500 000 70 kn load applications

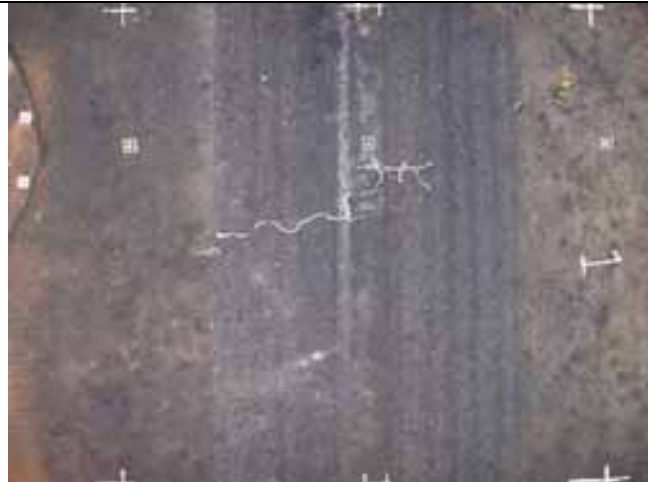
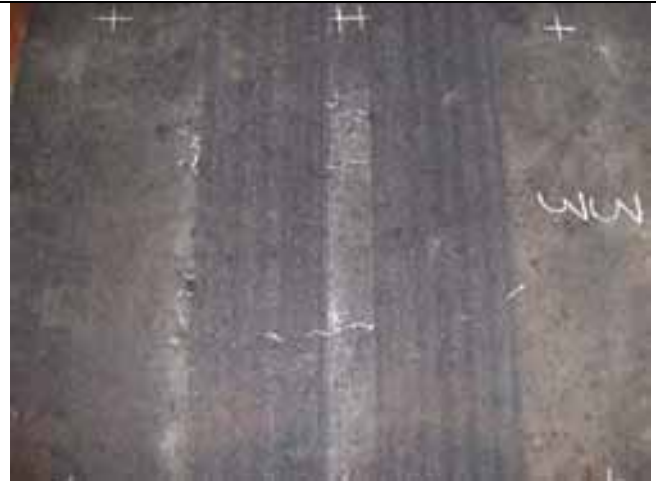
Plan views of test section with crack marked in white

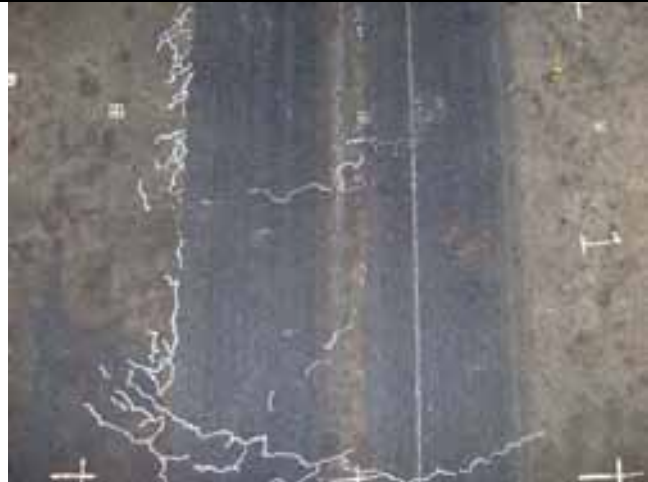
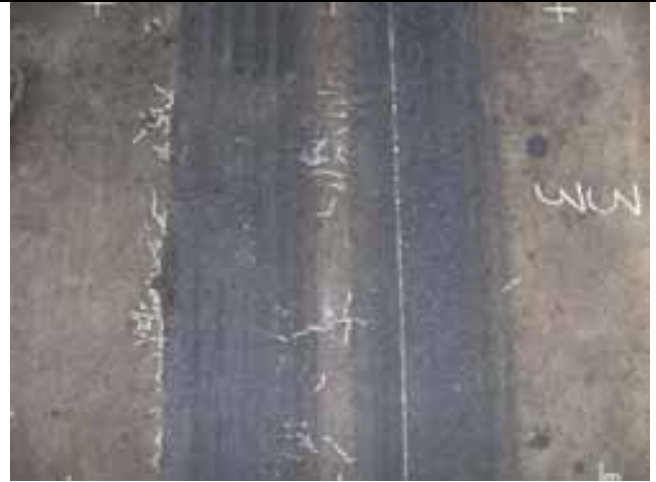
Plan views of test section with crack marked in white

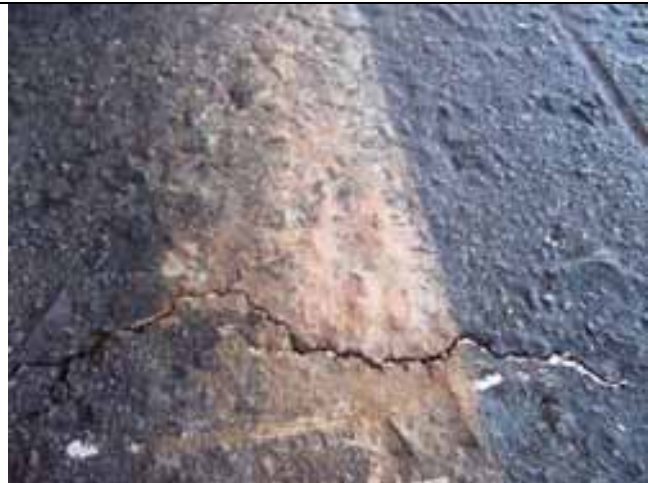
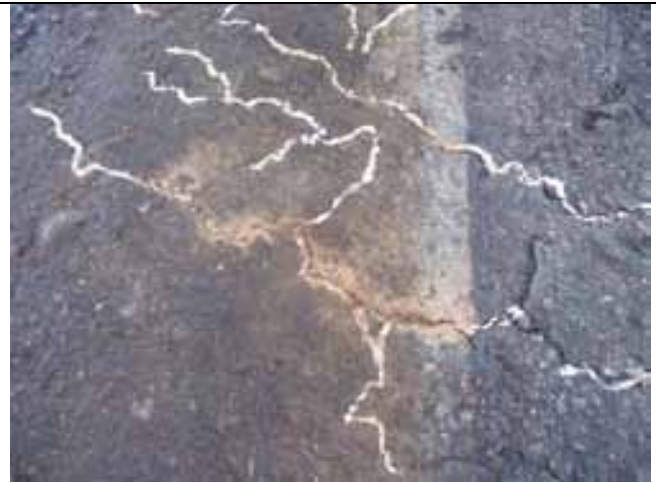
Close ups of material pumping through cracks in asphalt

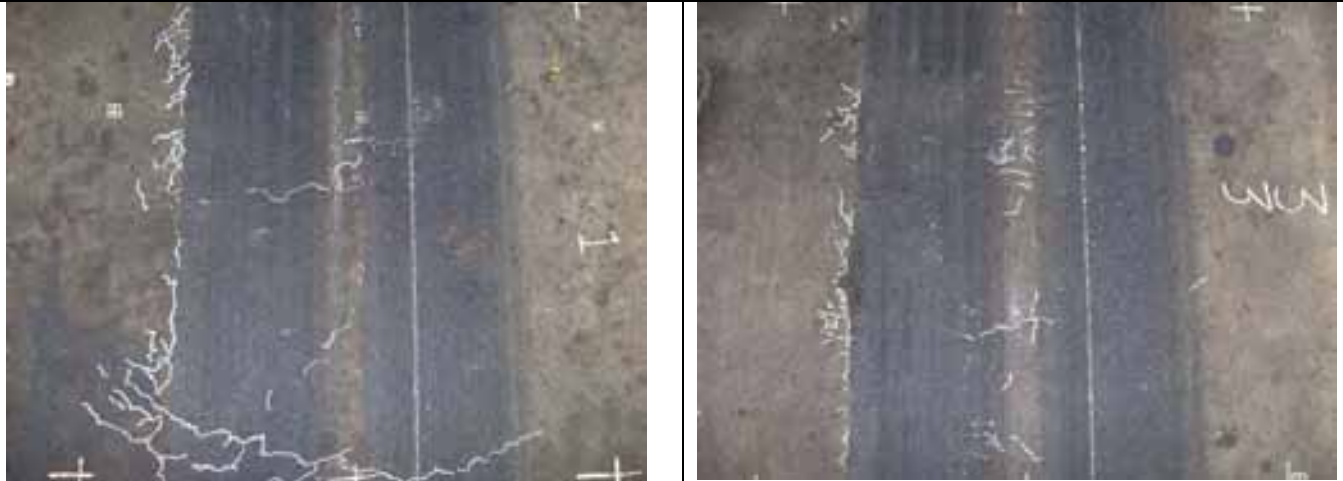
Plan views of test section

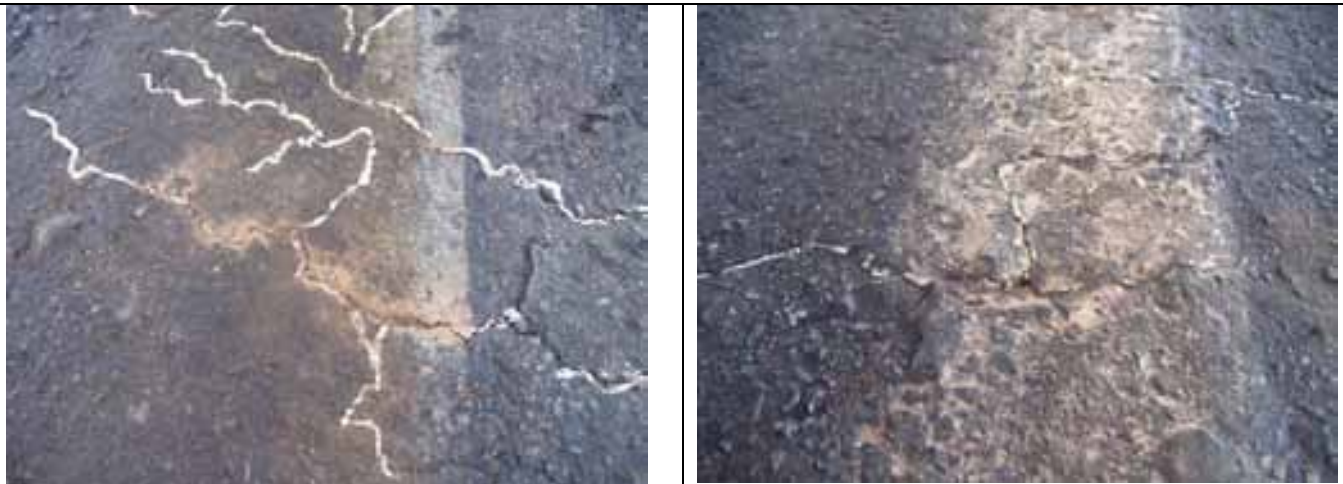
Close ups of material pumping through cracks in asphalt

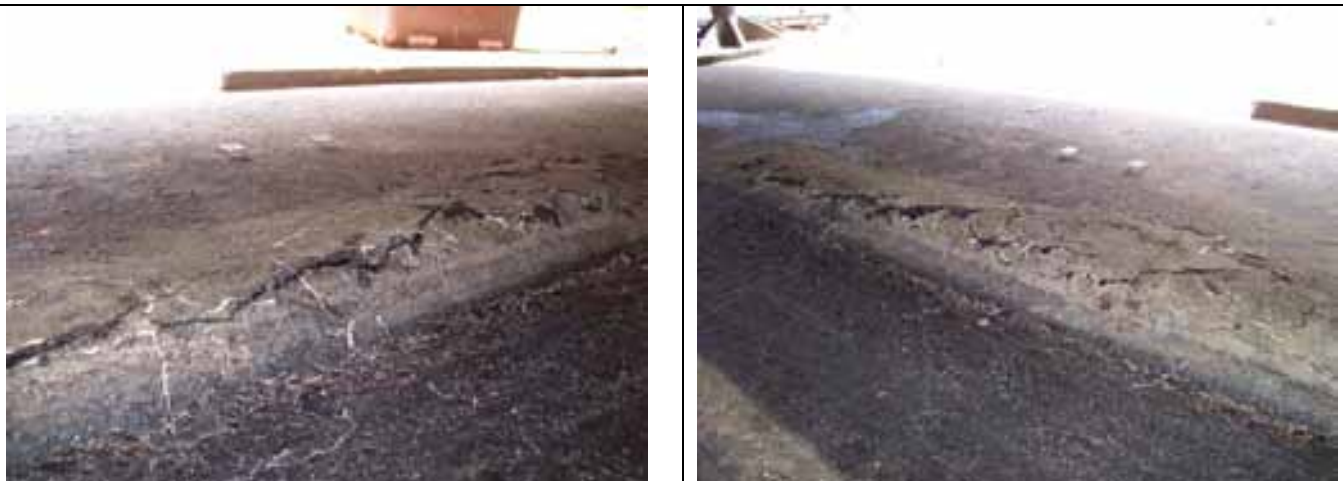
Vertical shear and disintegration on the sides of the wheeltrack

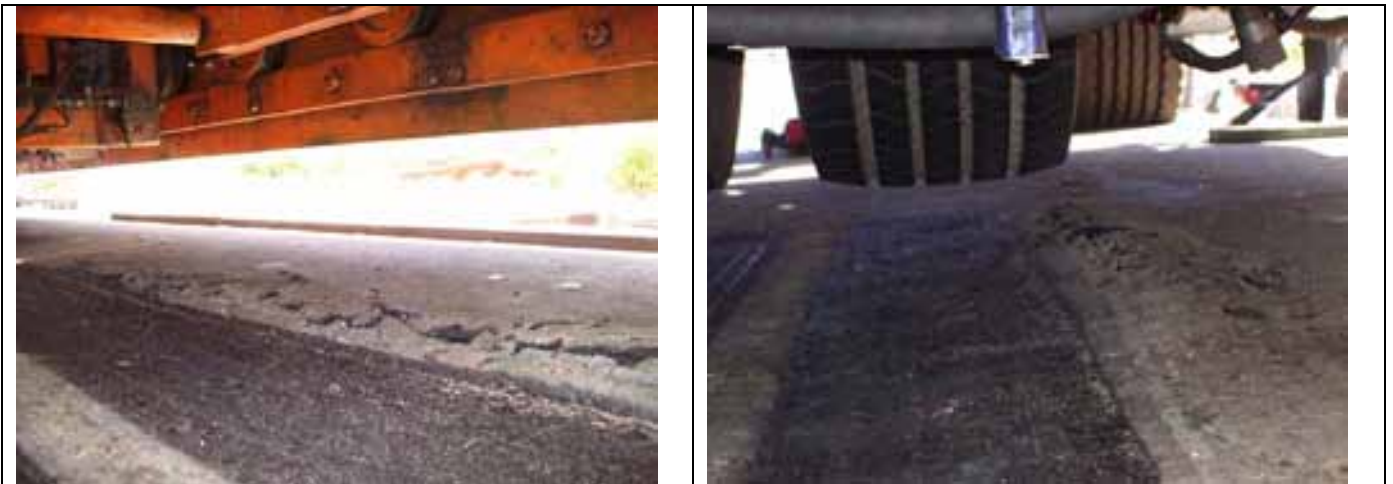
HMA heaving and cracking on the side of the wheeltrack

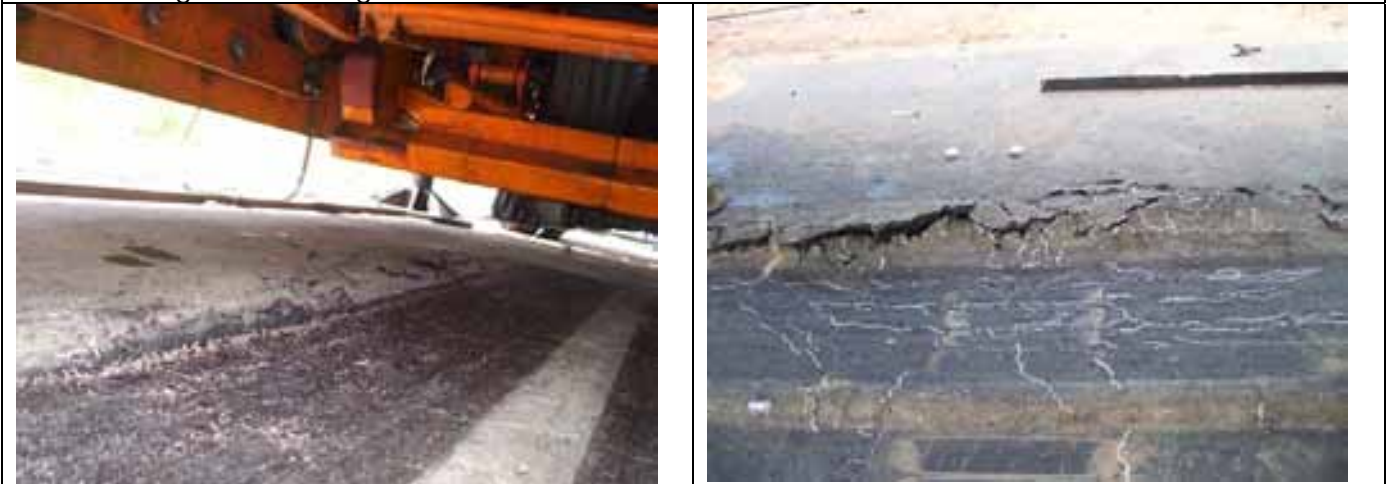
HMA heaving and cracking on the side of the wheeltrack

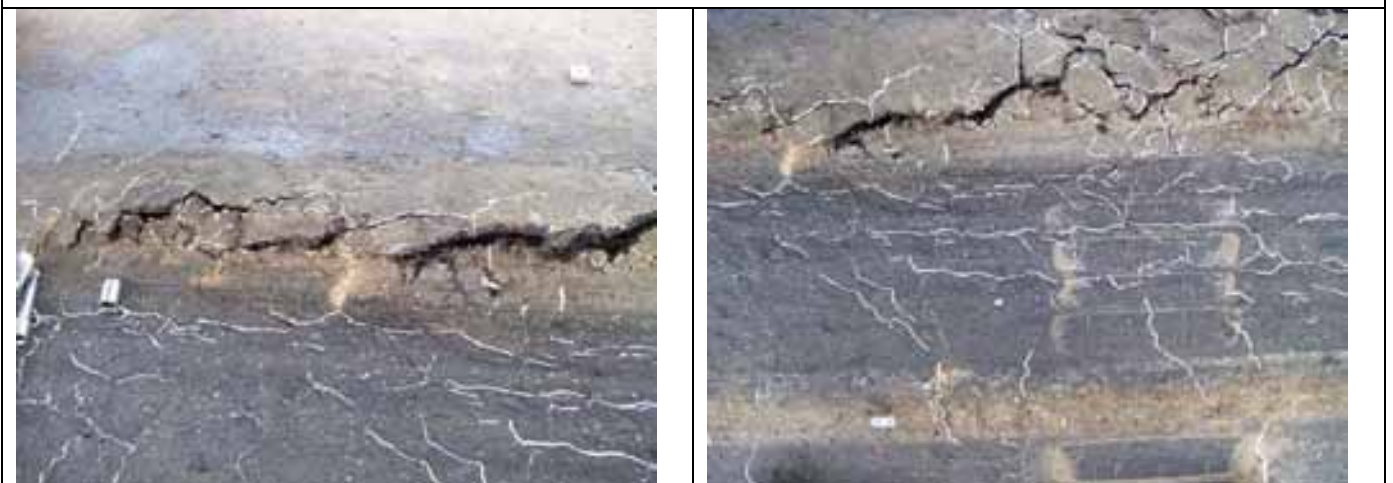
HMA heaving and cracking on the side of the wheeltrack. Note extensive crack pattern in wheeltrack

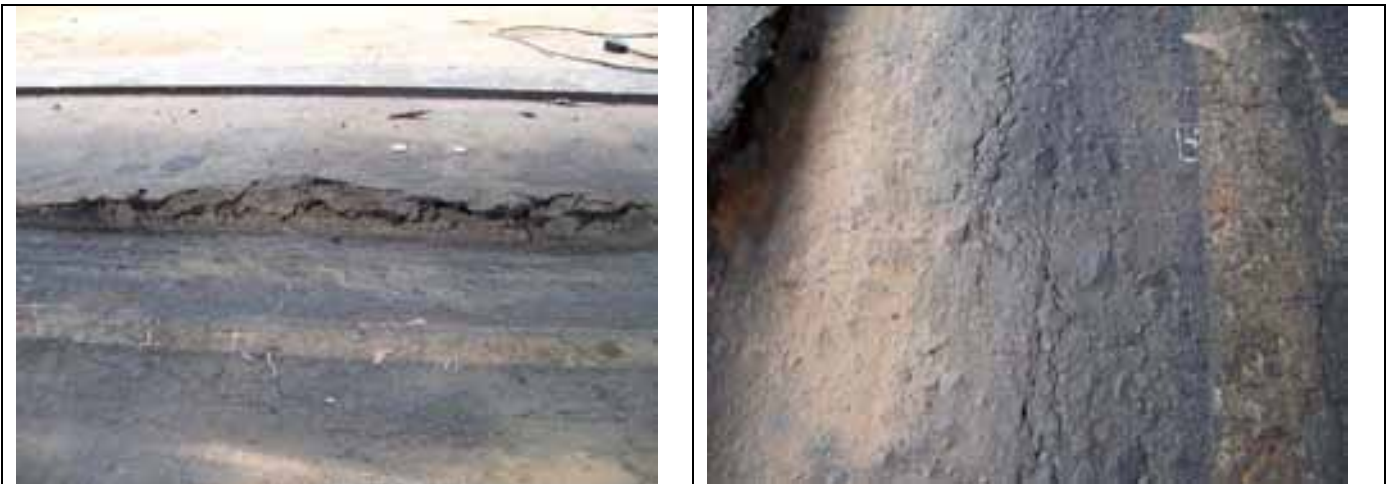
Heaved HMA on side of wheeltrack

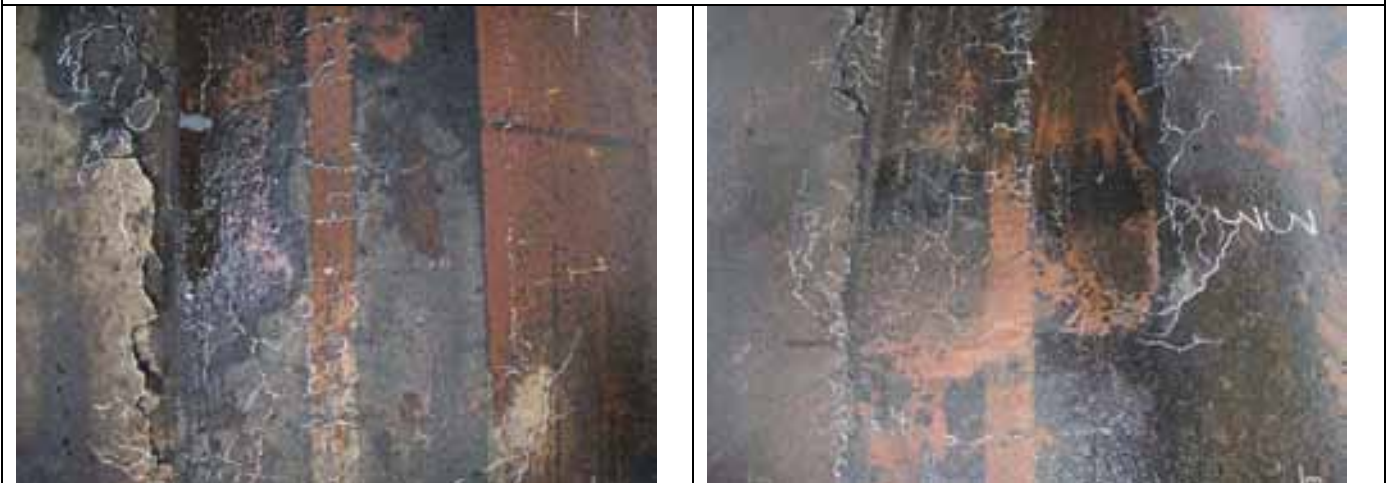
Plan views of base material pumped out of test section. Note extensive crack patterns

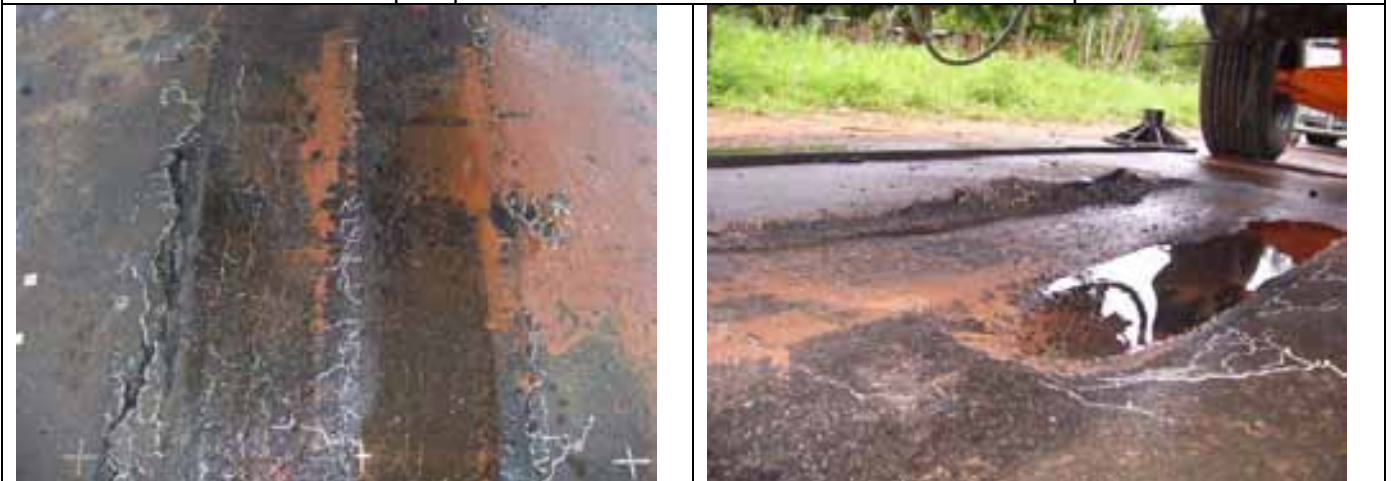
Plan and pictorial views of base material pumped out of test section. Note extensive crack patterns

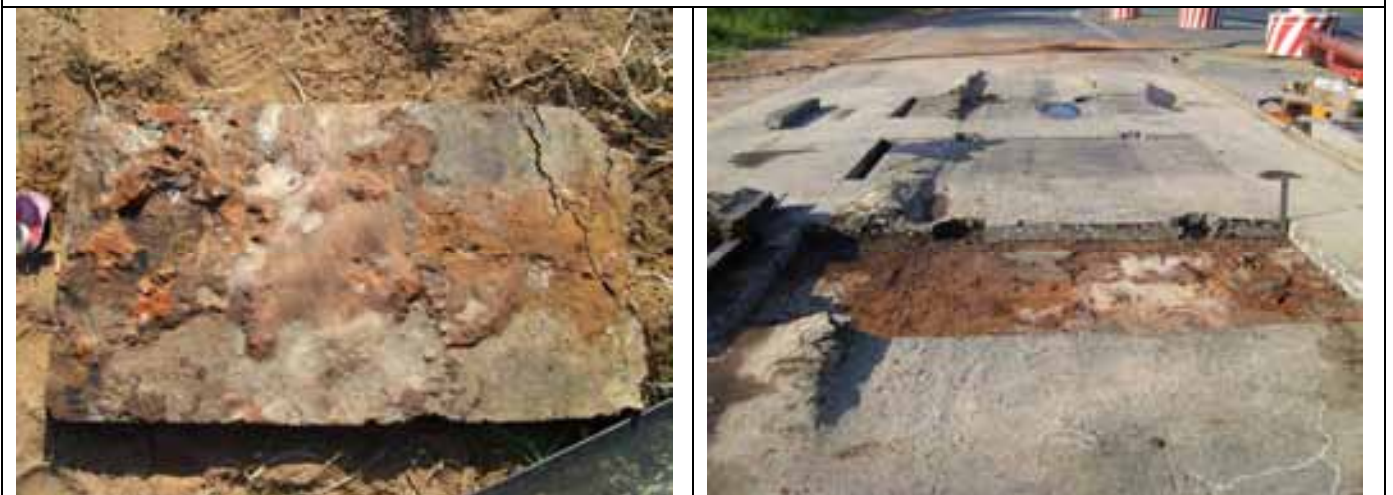
Underside of removed HMA mat. Note smoothed interface surface due to shear fatigue.

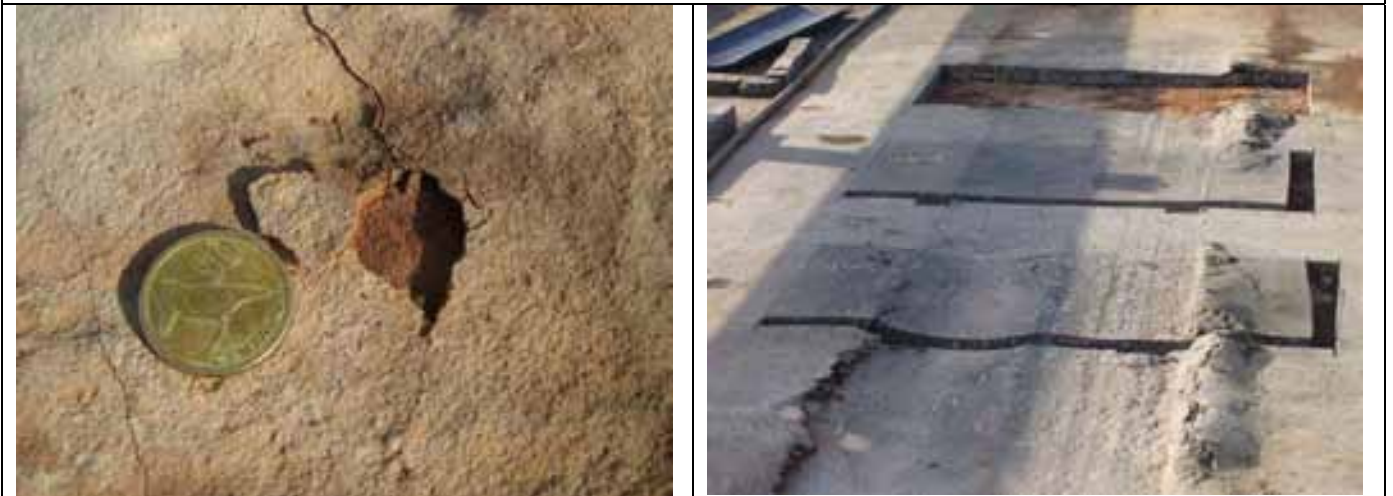
Close up of CTB surface after removal of HAM. Note smoothed surface texture.

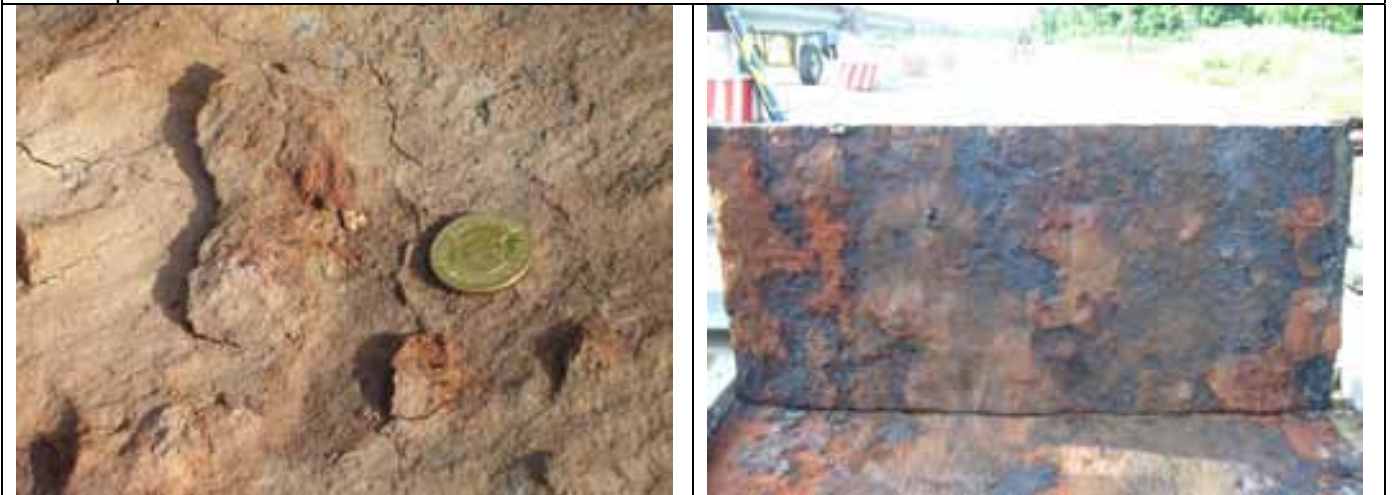
Close up of CTB surface after removal of HAM. Note smoothed surface texture. Underside of HMA mat removed from test pit 2.

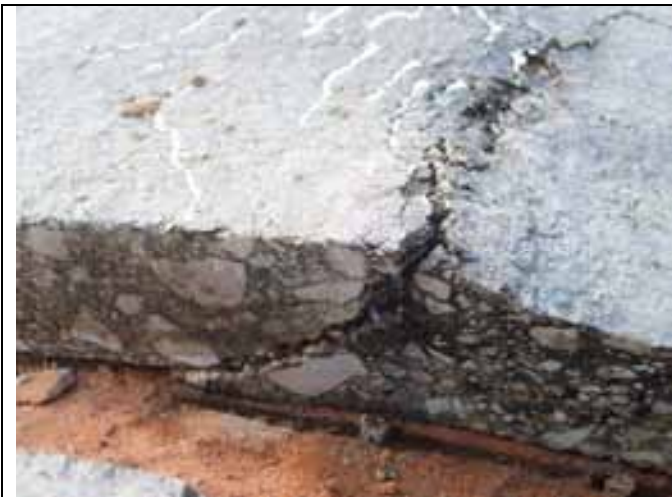
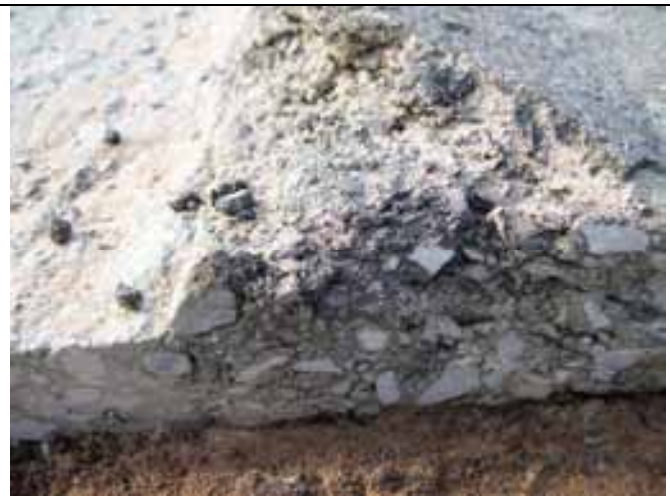
Close ups of HMA vertical shear

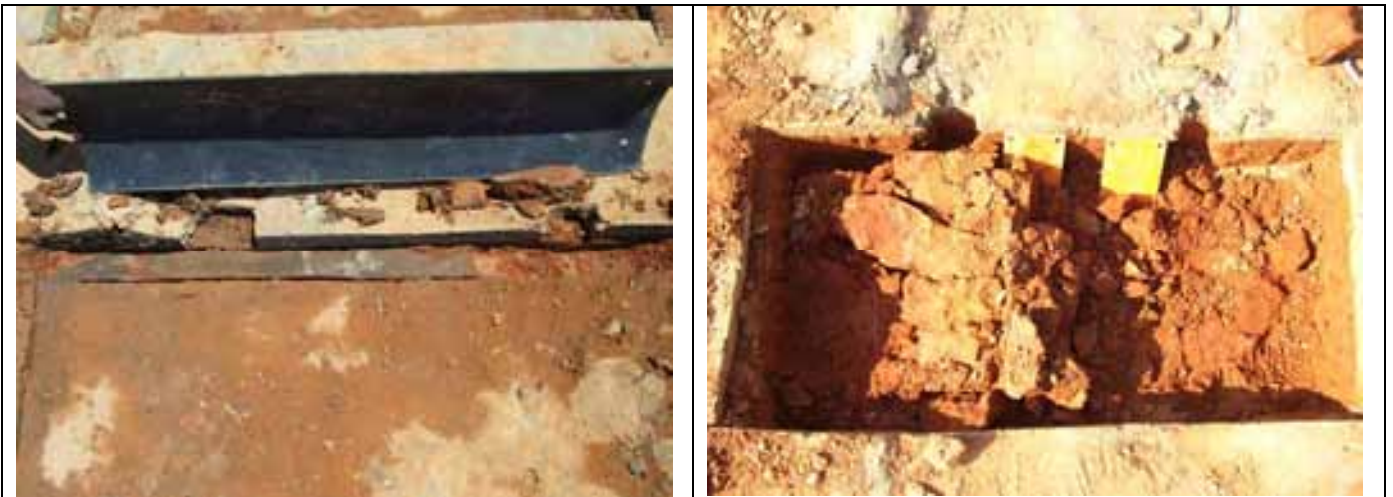
Removal of CTB fractures. Plan view of test pit during removal of CTB fractures note the size of the fractures.

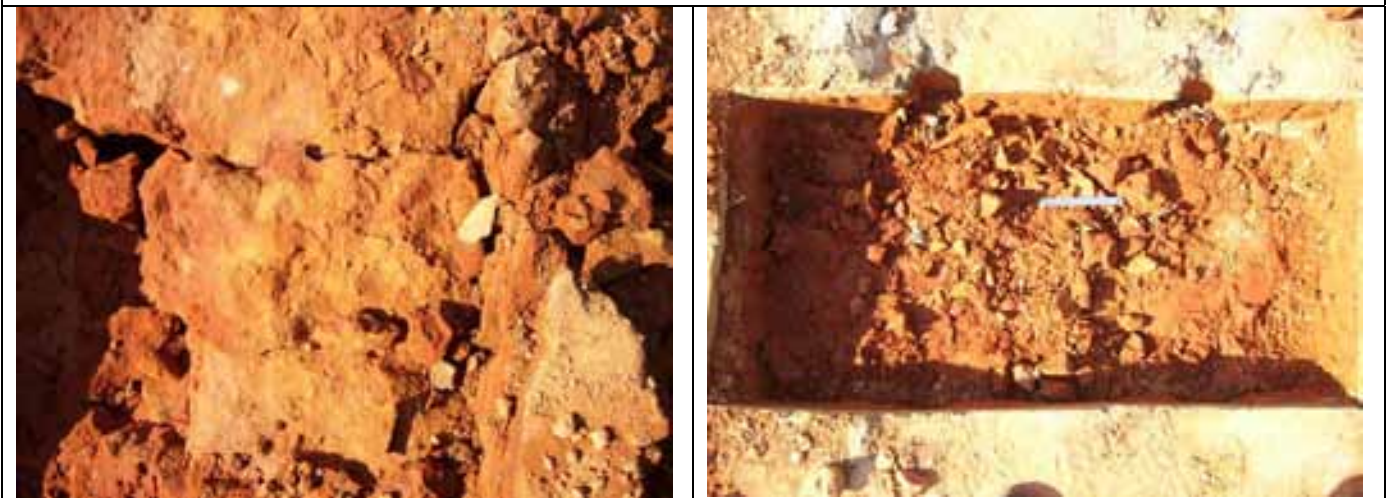
Fractured CTB and plan view of test pit after removal of CTB fractures.
