OVERLOADING CONTROL INFRASTRUCTURE SURVEY

Overview of Field Study

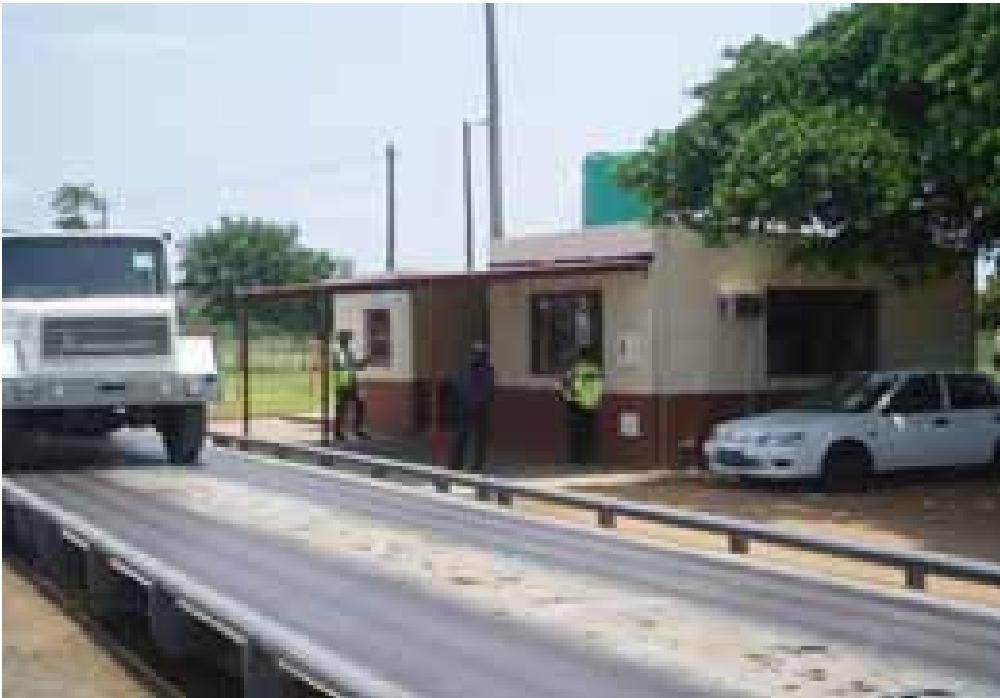
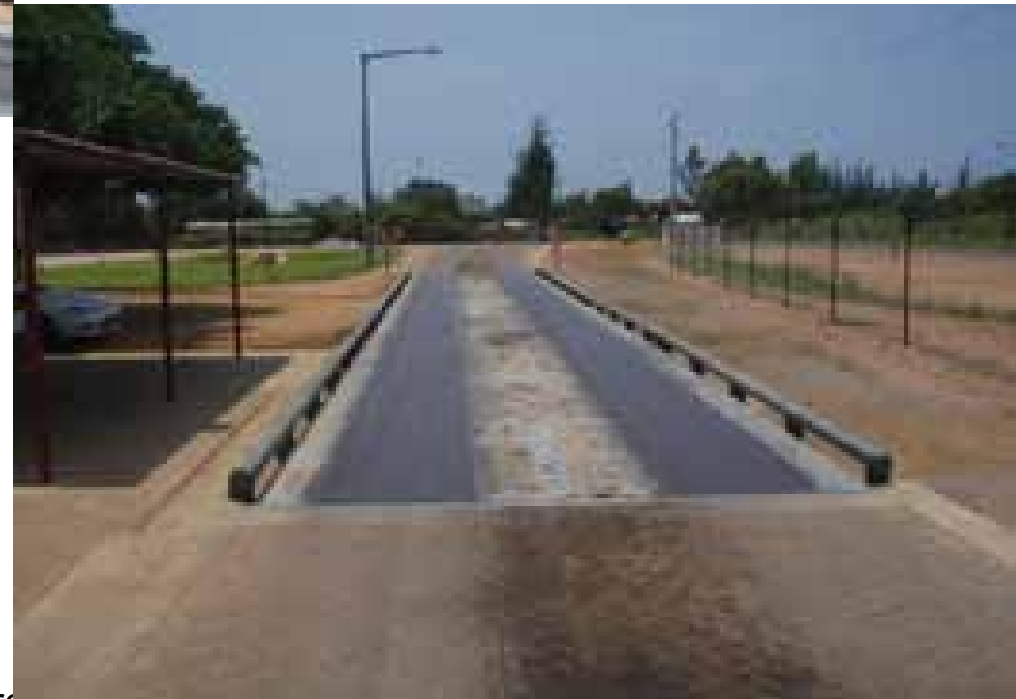
- Existing
- Avg. location – on EN2 at ± 5 km from EN2/EN4 intersection
- Close to Boane (Man & Maint by Private Operator)
- Utilities available
- Alternative roads - very poor (low standard)
- Equipment = Klerkscale Model KF100 22m x 3,2m scale (load cell)

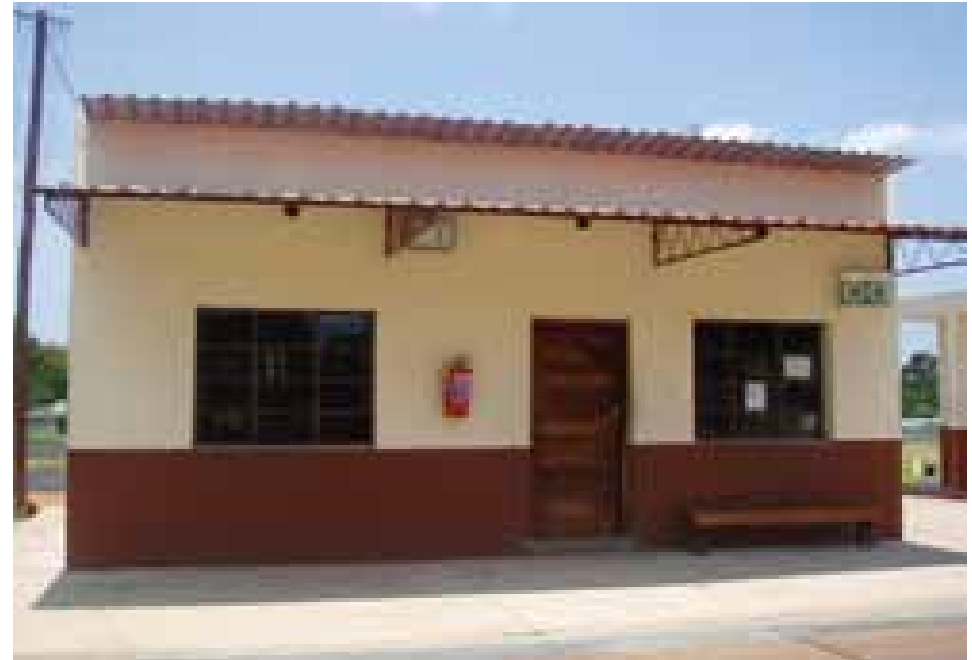
- Existing
- Avg. location – on EN4 $\pm 4,5$ km from EN4/EN2 intersection
- Close to Matola (Man & Maint by Private operator)
- Utilities available
- Alternative roads - very poor (low standard)
- Equipment = Klerkscale Model KD100 22m x 3,2m scale (load cell)

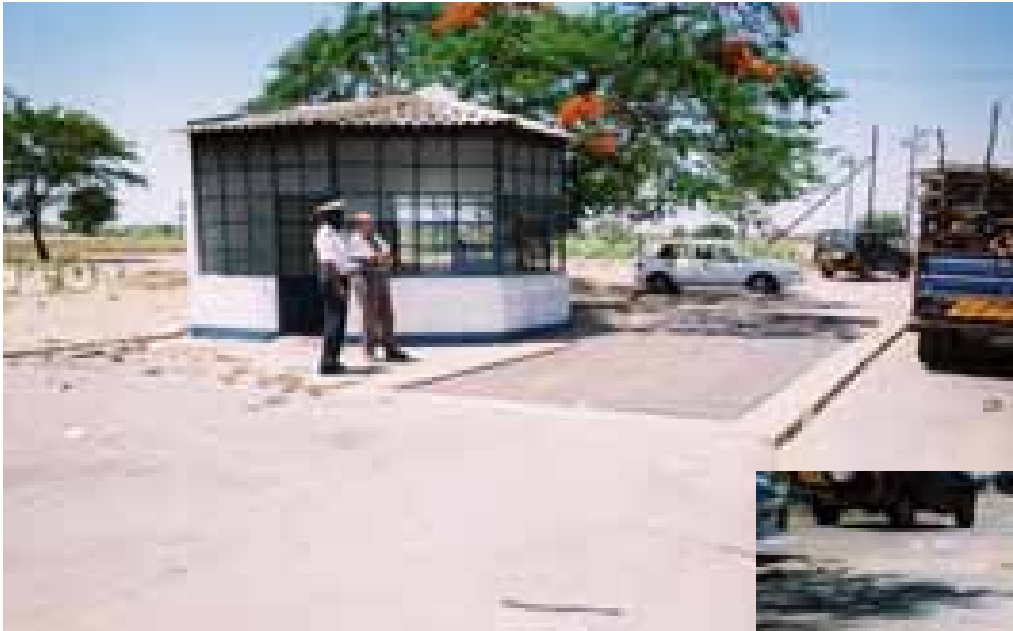
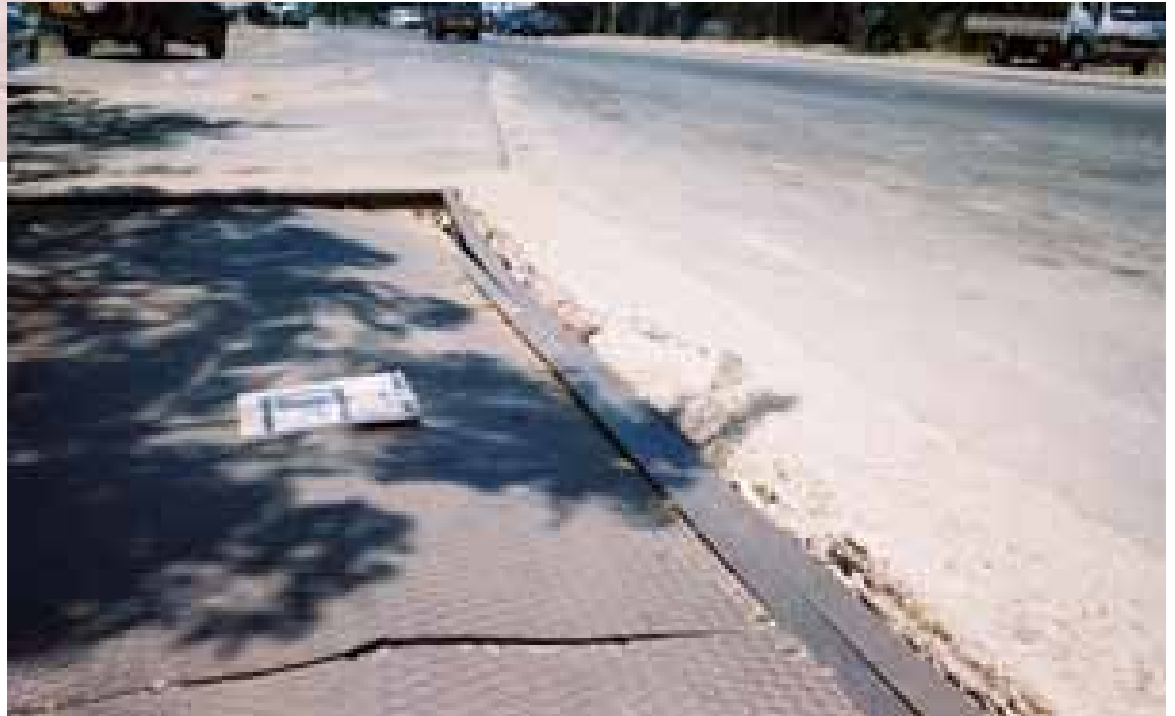
Michafutene (km14) demolished

- Demolished – new to be built
- Avg. location – on EN1 at police control point
- Close to Maputo (Man & Maint access)
- High traffic >1 100 Trucks/day
- Utilities available
- Road under rehab.
- Alternative roads - very poor (low standard)
- Equipment = none

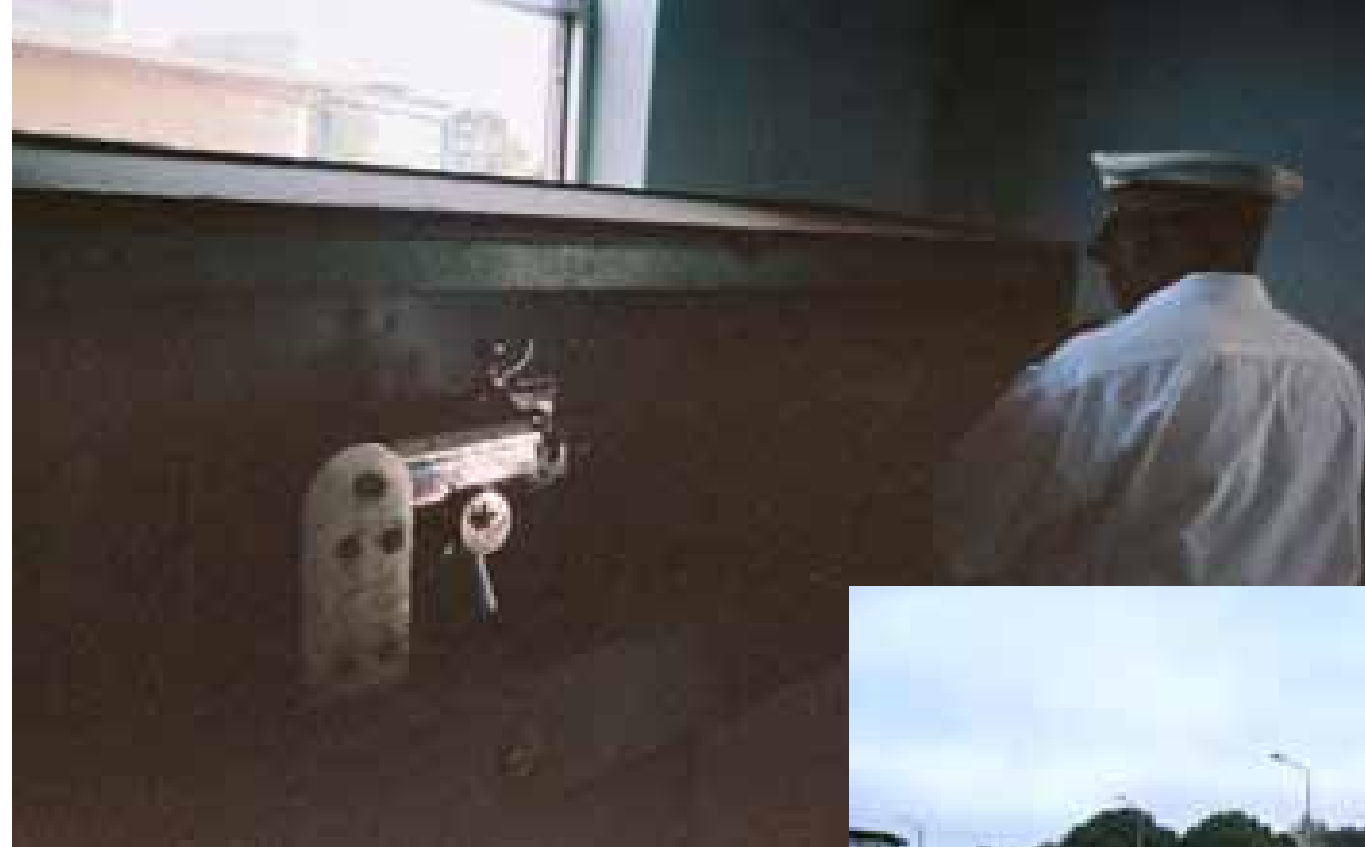
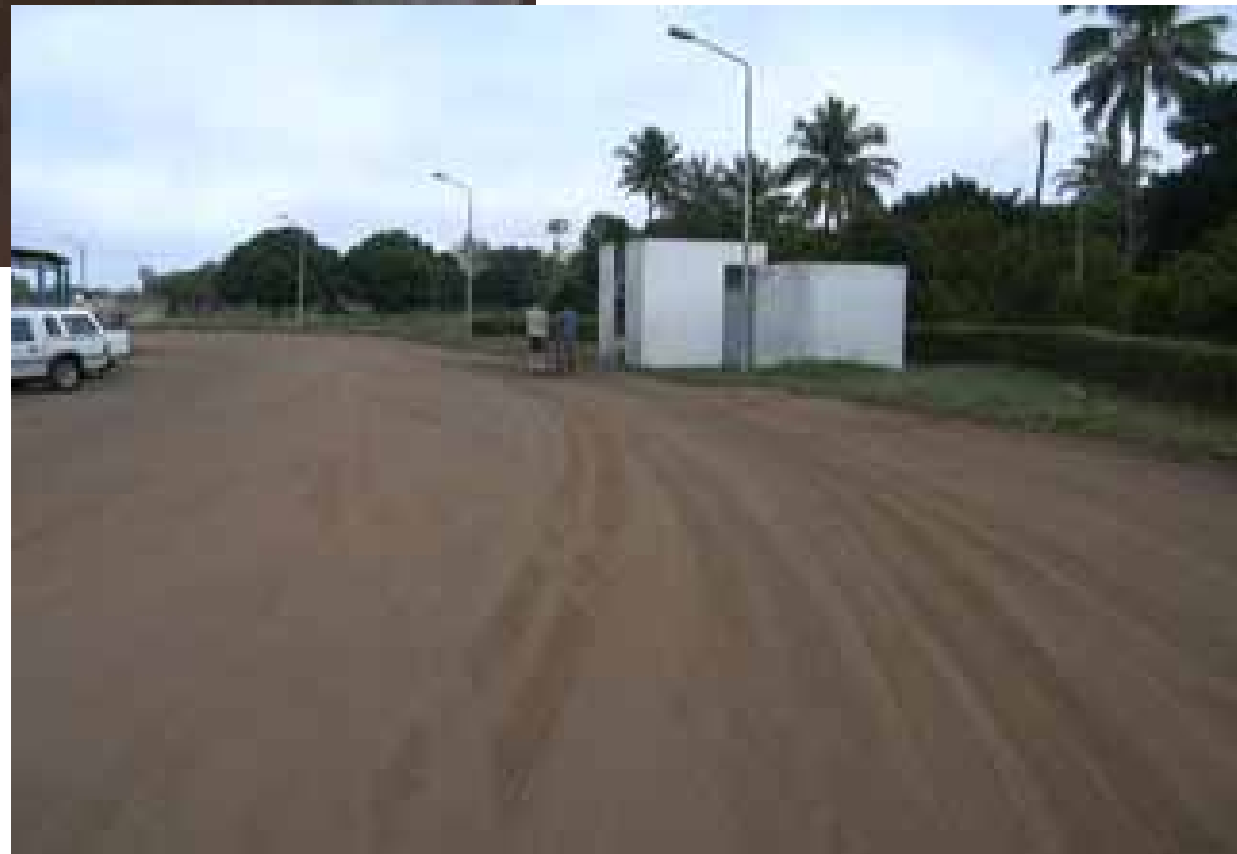
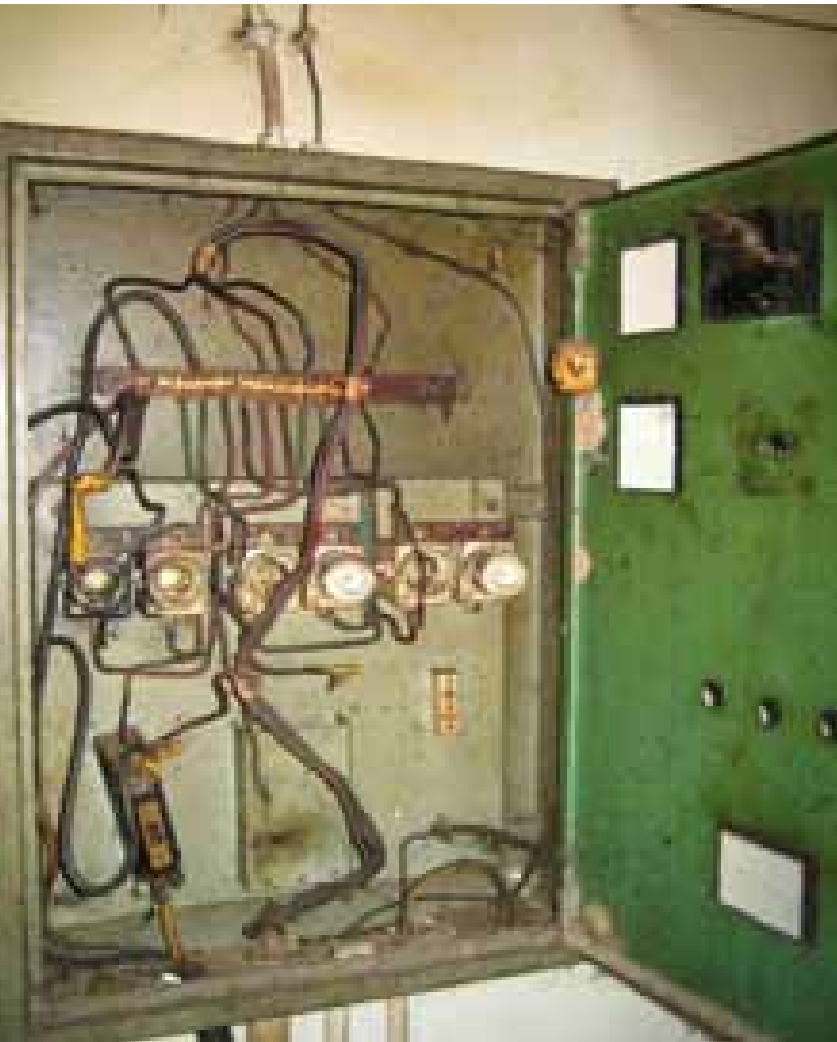
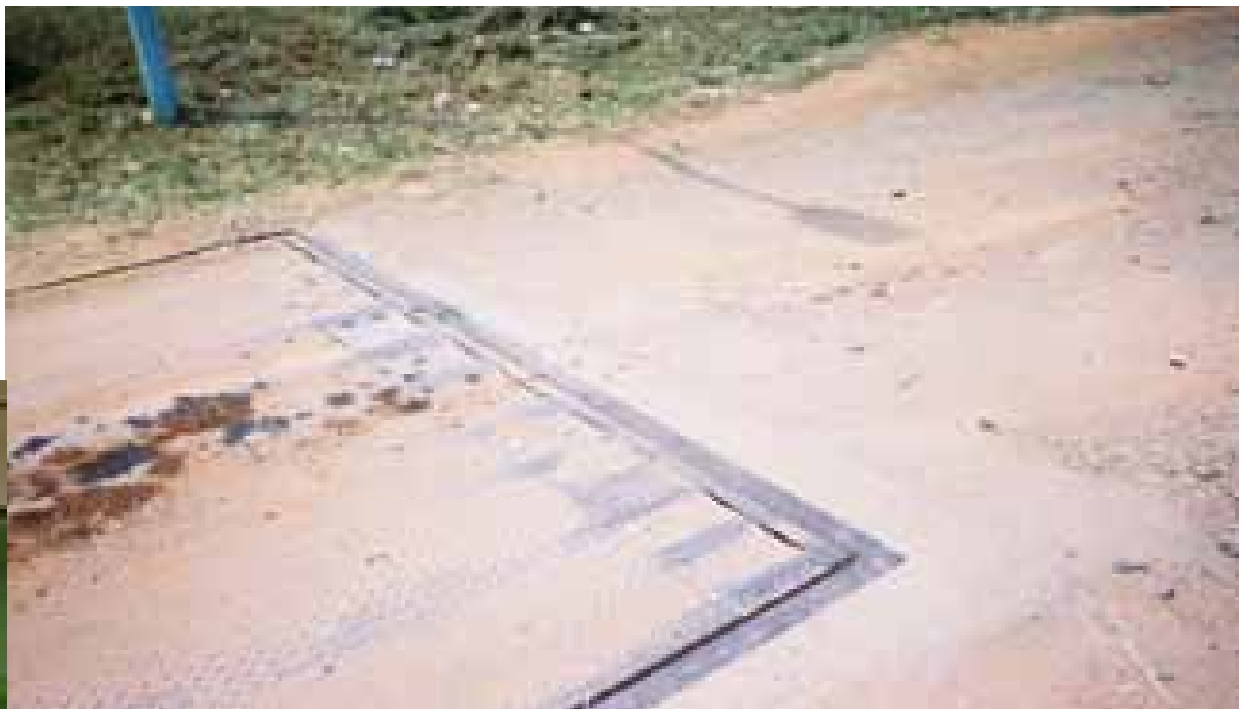
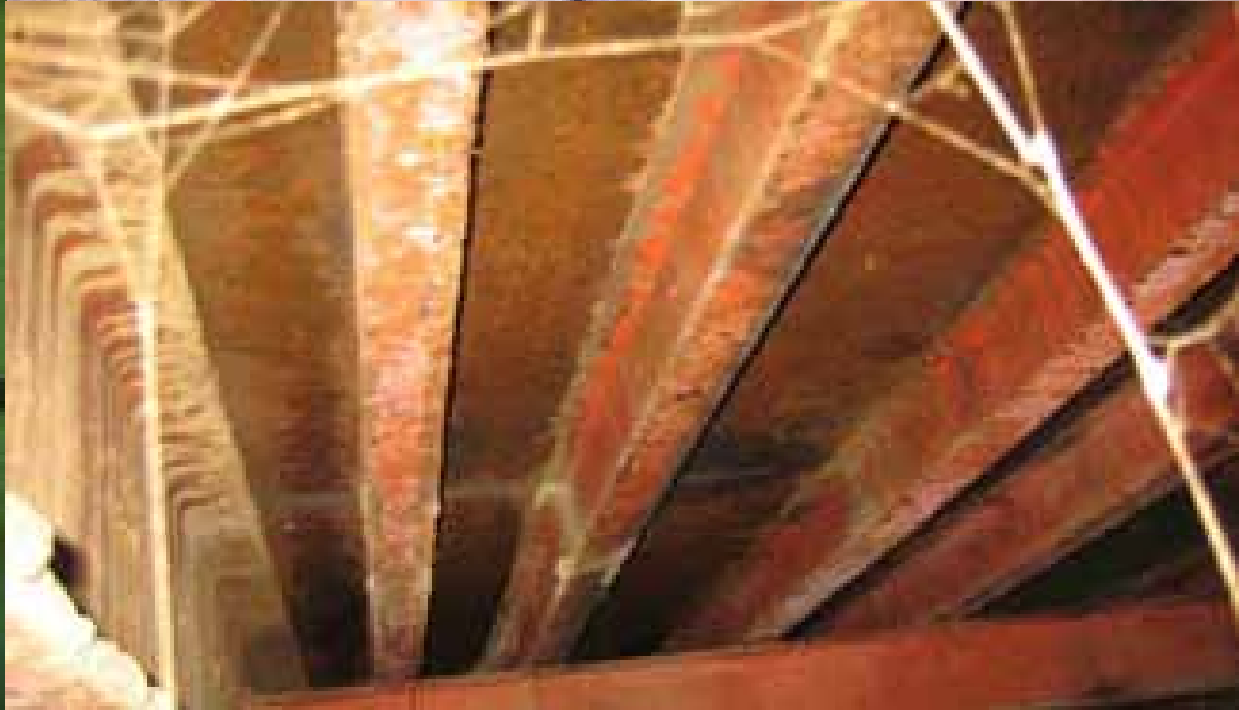
- Average location – on EN1 at police control point
- Just south of village Macia (77km from Maputo)
- Medium heavy vehicle traffic
- Electricity and water available
- Road under rehabilitation contract
- Alternative roads – few and very poor
- Equipment = mechanical 3m x 11m scale

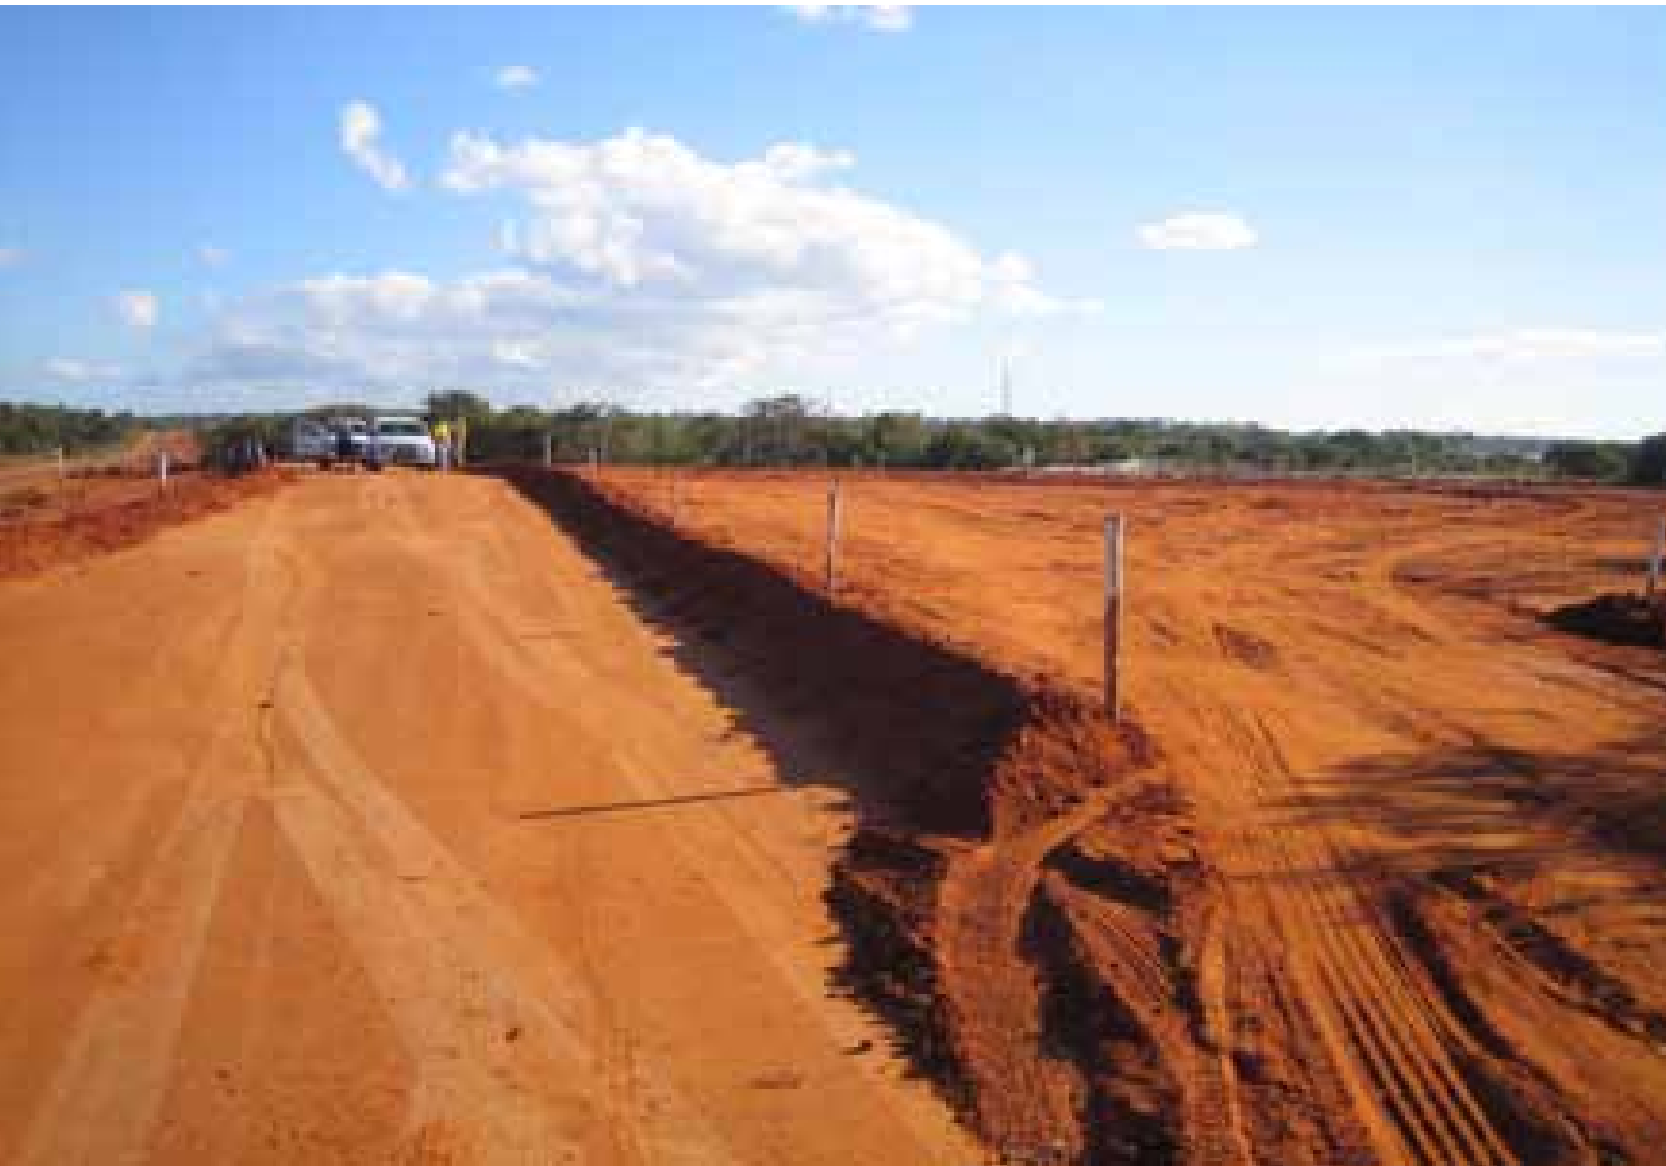
Inharrime (New Facility)

- New facility under construction
- Good location
- On EN1 just south of Inharrime (500km from Maputo)
- Low traffic <100 Trucks/day
- No utilities (to be provided under contract)
- Road under rehabilitation contract
- Alternative roads – none
- Equipment = 3m x 4m electro-mechanical scale

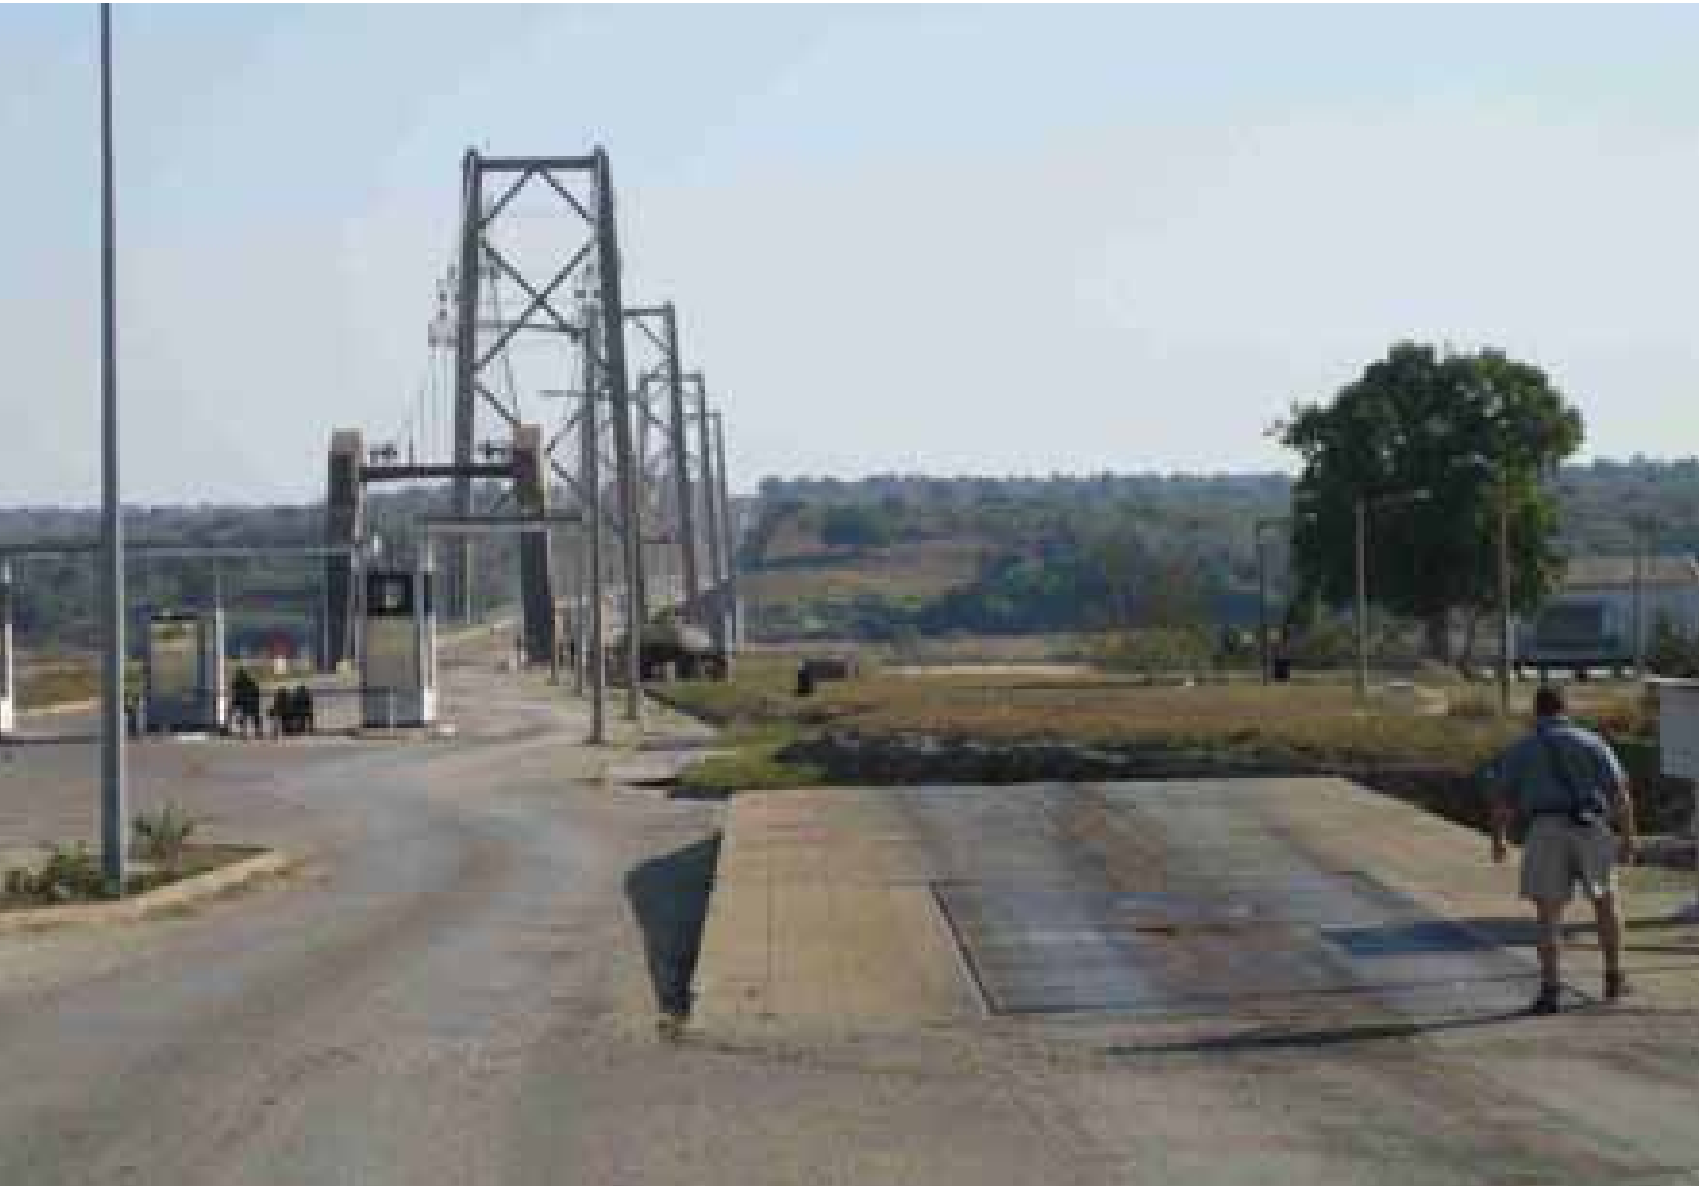
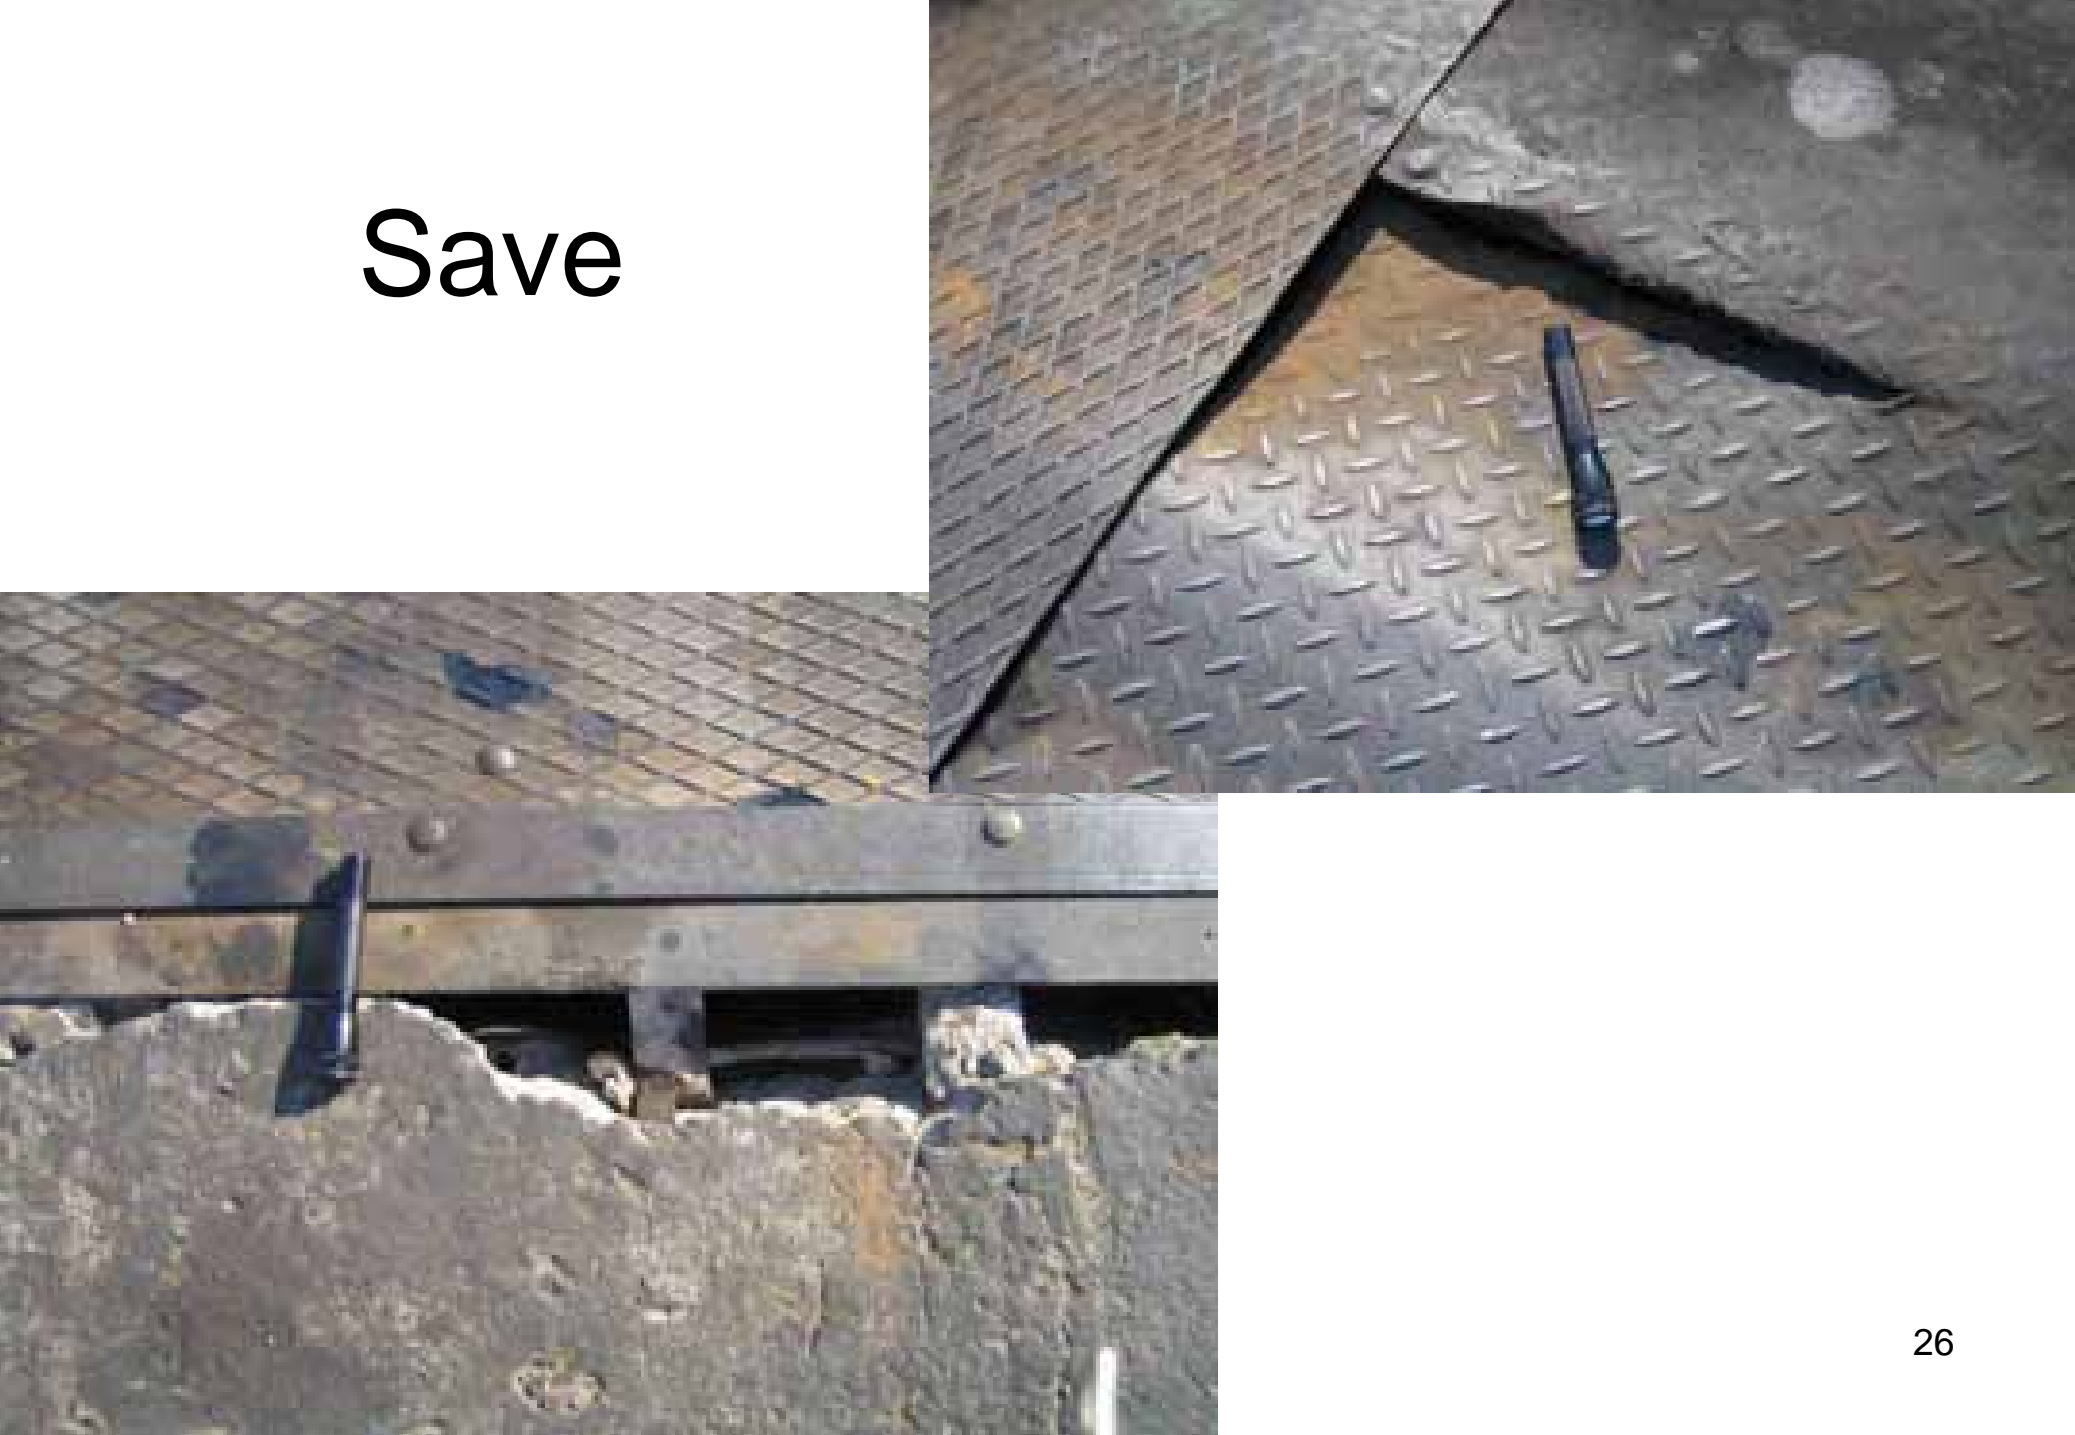
- Existing old single deck mechanical scale
- Scale operational and in reasonable condition
- Good location – on EN1 at Bridge over Rio Save
- At police control and town of Save
- Medium to low traffic (all long haul)
- Limited utilities (generated power from town, radio communication)
- No parking area
- Alternative roads – none (Rio Save cut off)
- Buildings run down – used for domestic purposes
- No building at scale (scale house)
- Random manual selection

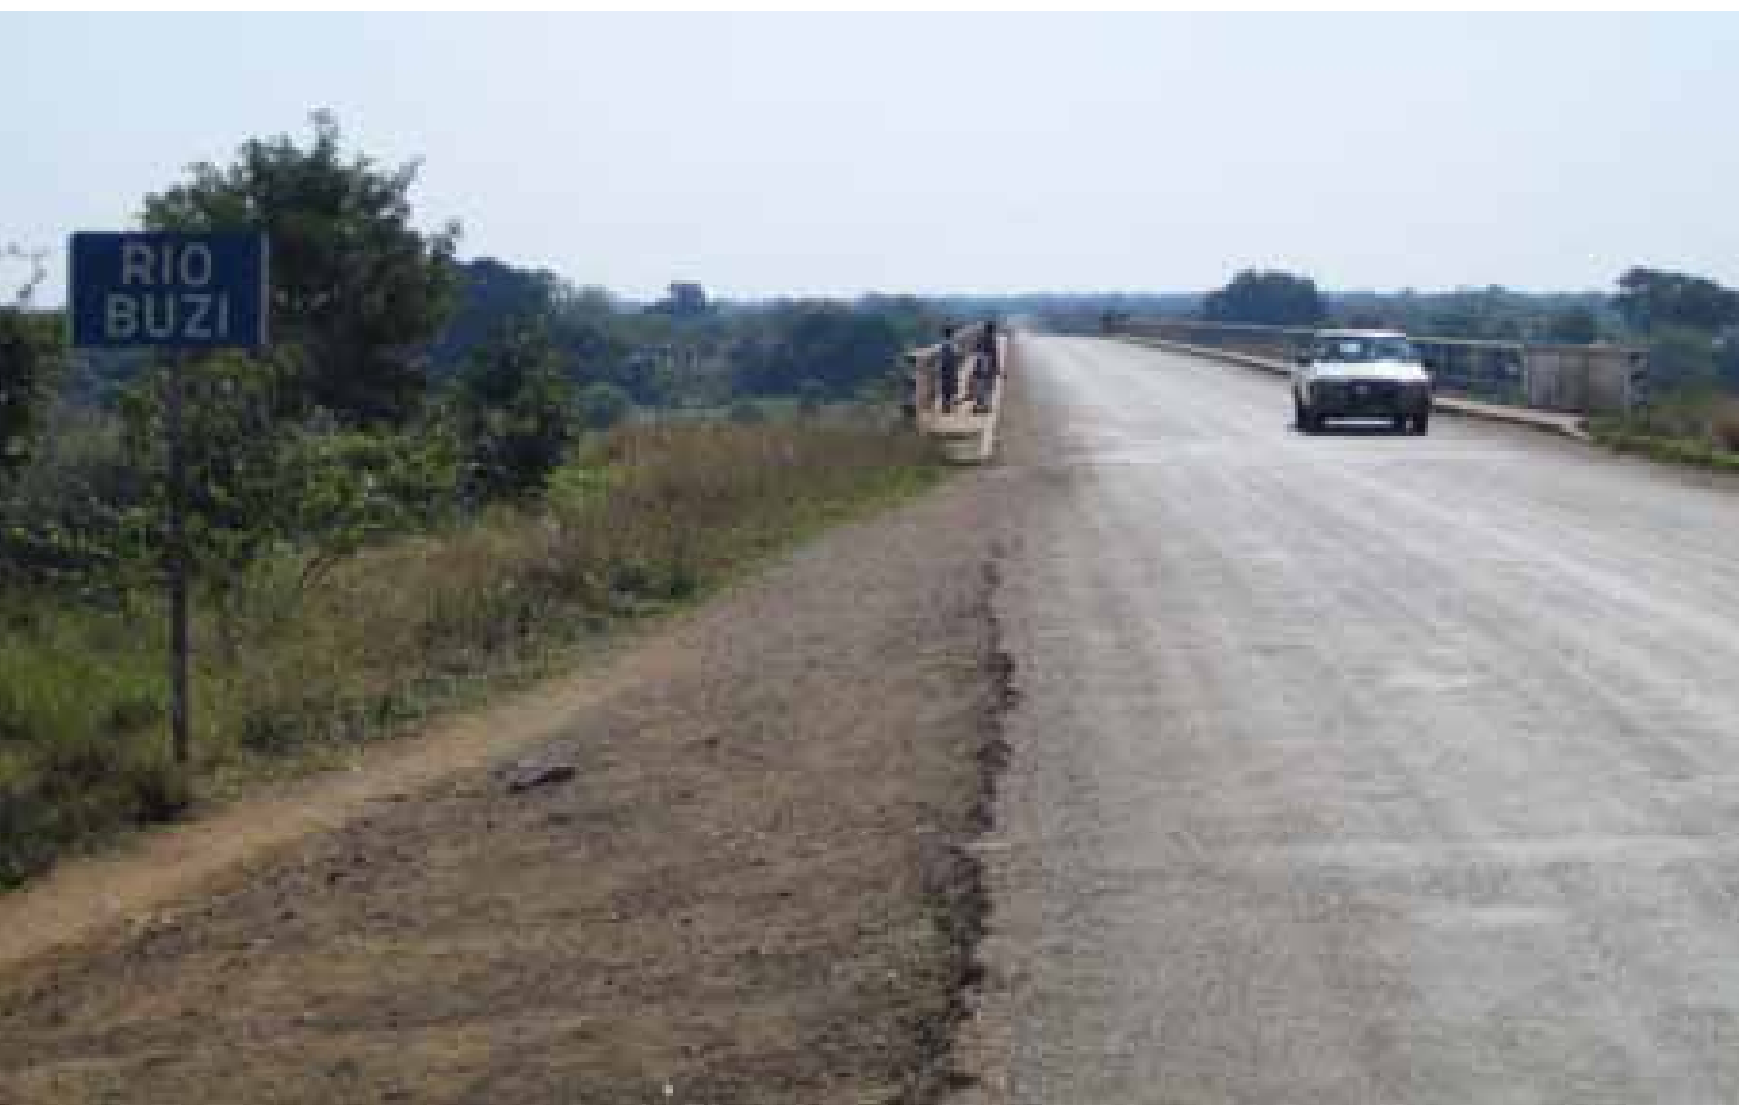
- Proposed location on EN1 north of bridge over Rio Buzi
- Approx 100km from Inchope and 140km from Beira
- Good location – no alternative routes
- At police control and town
- Low traffic (all long haul)
- Utilities available from town

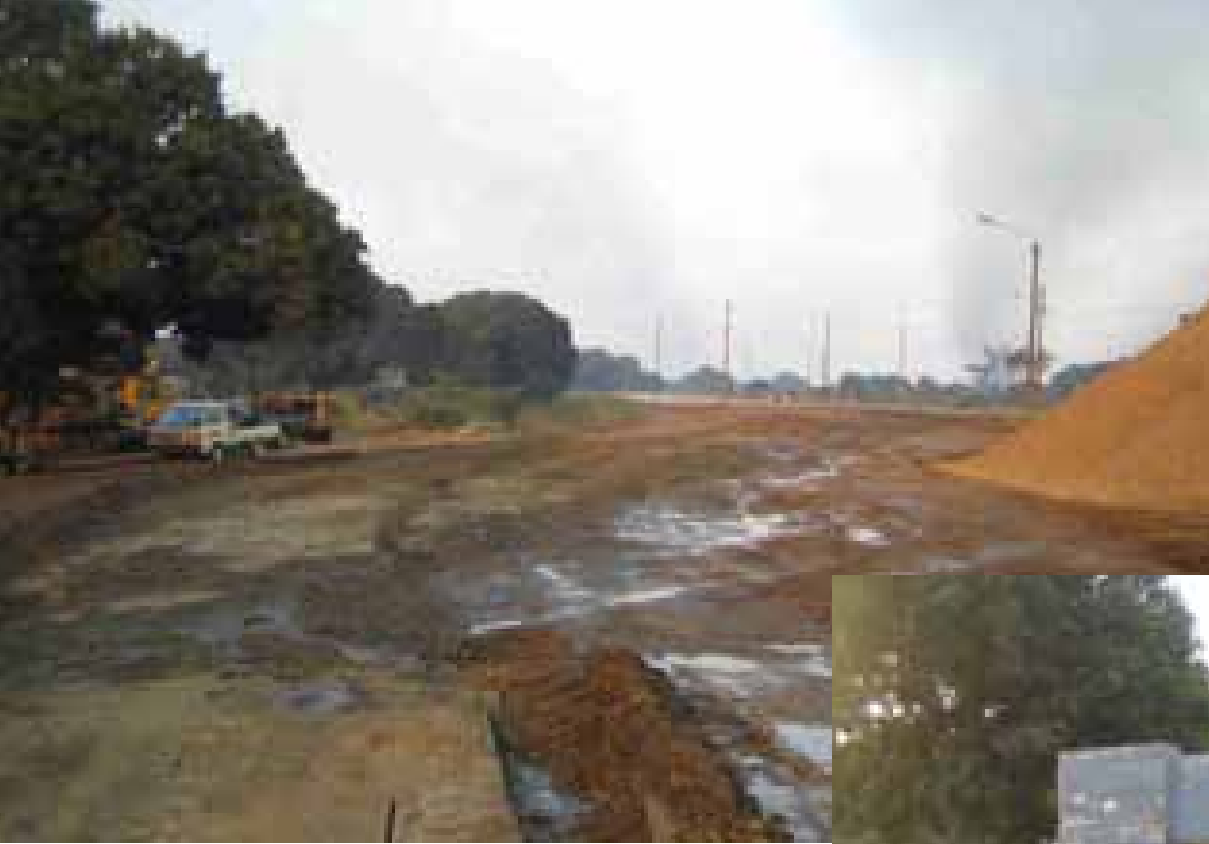
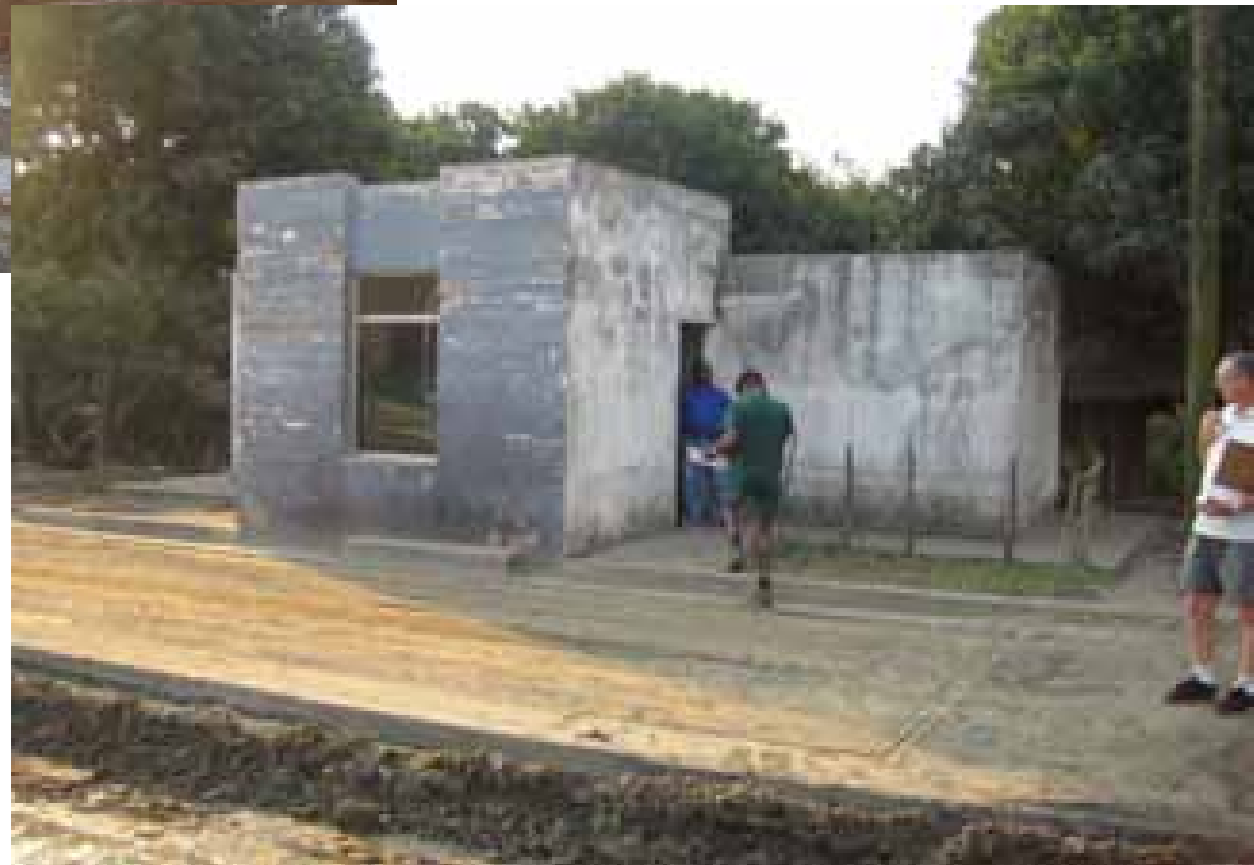
Dondo

- Existing location on EN6 20km east of Beira
- On Beira Corridor Alternative routes to Muanza (turnoff close by)
- At police control and town
- Medium to high traffic (mostly long haul)
- Utilities available from town
- Facilities (currently being rehabilitated) incl.:
 - Standard layout (see Macia)
 - Single deck mechanical scale in poor condition
 - Buildings in poor state (no dedicated scale office in use)
 - Toilet facilities not usable
 - No designated truck parking area
 - Gravel approaches under rehabilitation
 - No road signage to get trucks to weighbridge
